Facility Condition Assessment Report

Peachtree Middle Facility Executive Summary ReportReport Date: 24 Jun 2011

Facility: \Middle Schools\Peachtree Middle**Address:** 4664 North Peachtree Road, Dunwoody, GA 30338**Attributes:**

Peachtree Middle Detailed Facility Needs Assessment Report

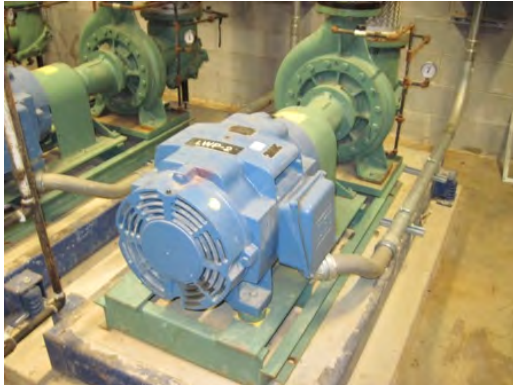
Assembly: **D3040**
System: **Distribution Systems & Exhaust Systems**
Material: **Circulating Pump Double Suction**
Distress: **Needs Remediation**
Category: **Deferred Maintenance**
Correction: **Replace Circulating Pump Double Suction**
Note: **The number one circulation pump is malfunctioning and should be replaced.**

Raw Cost	\$1,932.00
Plus or (Minus) Additional Cost	\$734.16
Total Estimated Amount	\$2,666.16

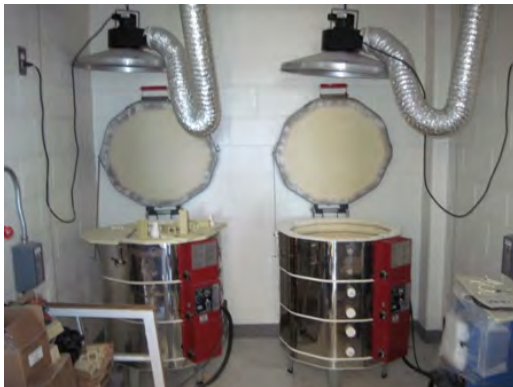
Assembly: **D3040**
System: **Distribution Systems & Exhaust Systems**
Material: **Roof Exhaust Fan Systems**
Distress: **Inadequate**
Category: **Code Compliance**
Correction: **KILN Exhaust System incl fixed hood roof exhaust**
Note: **The kiln exhaust systems are inadequate and should be replaced.**

Raw Cost	\$24,012.30
Plus or (Minus) Additional Cost	\$9,124.67
Total Estimated Amount	\$33,136.97

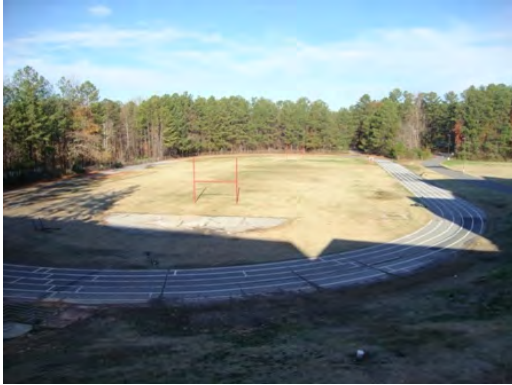
Assembly: **F1040**
System: **Special Facilities - Footbal Field - Natural Turf System**
Material: **Beyond Service Life**
Distress: **Beyond Service Life**
Category: **Deferred Maintenance**
Correction: **Renew System**
Note: **The football field needs to be reseeded.**

Raw Cost	\$3,564.00
Plus or (Minus) Additional Cost	\$926.64
Total Estimated Amount	\$4,490.64

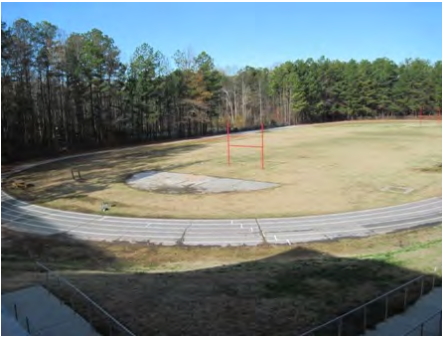
02-Dec-2010
Track at Peachtree Middle School

Current Repair Cost: \$146,230.48**Replacement Cost:** \$166,868.23**FCI:** 87.63%

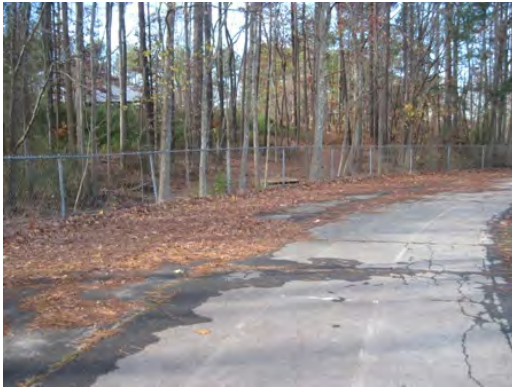
Assembly: **F1040**
System: **Special Facilities - Running Track Surface & Curbing System**

Material: **Needs Remediation**
Distress: **Needs Remediation**
Category: **Deferred Maintenance**
Correction: **Renew System**

Note: **The running track surface is damaged and should be replaced.**

The track is asphalt that is in poor condition. There is a large grass area in addition to the football field.

Raw Cost	\$116,055.94
Plus or (Minus) Additional Cost	\$30,174.54
Total Estimated Amount	\$146,230.48
