Facility Condition Assessment Report

Rowland Elementary Facility Executive Summary ReportReport Date: 05 Jul 2011

Facility: \Elementary Schools\Rowland Elementary**Address:** 1317 S. Indian Creek Drive, Stone Mountain, GA 30083**Attributes:****Facility Code** 4065
Super Cluster 5**General Information:****Function:** Elementary School
Gross Area: 64,528 S.F.**Year Built:**
Last Renovation:**Facility Description:**

Rowland Elementary Detailed Facility Needs Assessment Report

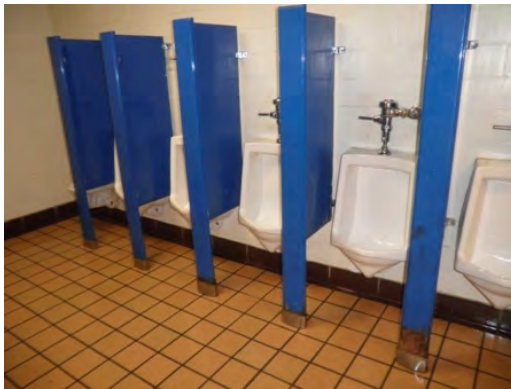
Assembly: **C1030**
System: **Fittings**
Material: **Toilet Partitions**
Distress: **Needs Remediation**
Category: **Deferred Maintenance**
Correction: **Replace Toilet Partitions**
Note: **The building fittings are damaged and should be replaced. The toilet partitions and the reinforcement that mounts to them floor are rusted.**

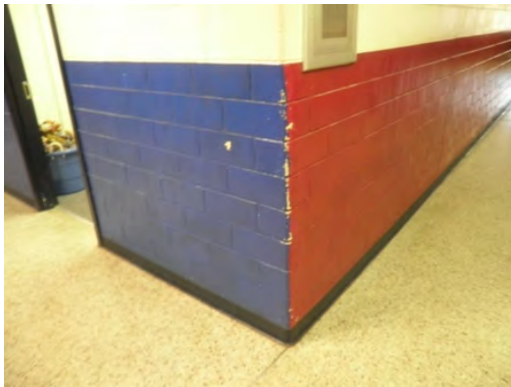
Assembly: **C3010**
System: **Wall Finishes - Paint**
Material: **System**
Distress: **Damaged**
Category: **Deferred Maintenance**
Correction: **Renew System**
Note: **The wall paint is aged and scuffed and should be repainted.**

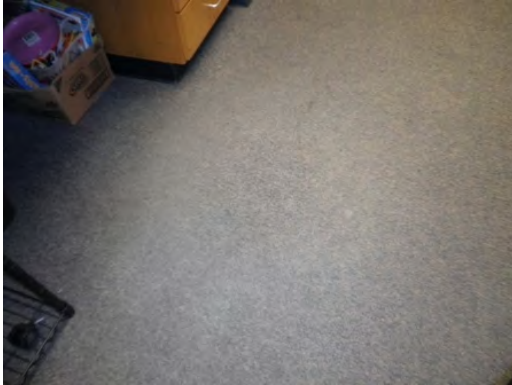
Assembly: **C3020**
System: **Floor Finishes - Carpet**
Material: **Carpet**
Distress: **Needs Remediation**
Category: **Deferred Maintenance**
Correction: **Replace Carpet**
Note: **The carpet in the front office area is worn due to heavy traffic and should be replaced.**

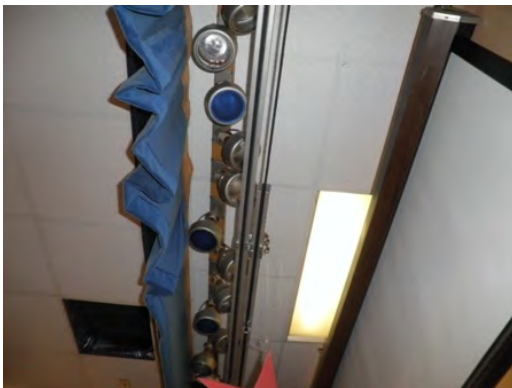
Assembly: **E1020**
System: **Institutional Equipment**
Material: **System**
Distress: **Beyond Service Life**
Category: **Deferred Maintenance**
Correction: **Renew System**
Note: **The stage lighting and curtain are aged and should be replaced.**

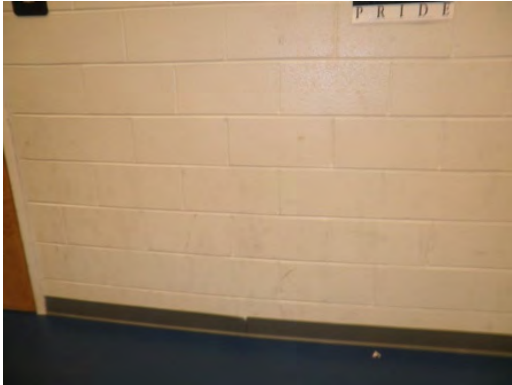
Assembly: **C3010**
 System: **Wall Finishes - Paint**
 Material: **System**
 Distress: **Beyond Service Life**
 Category: **Deferred Maintenance**
 Correction: **Renew System**
 Note: **The wall paint is aged and scuffed and should be repainted.**

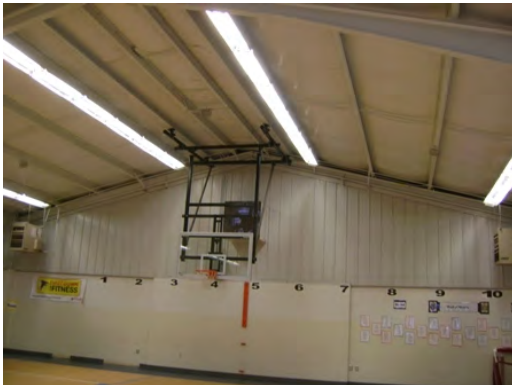
Assembly: **D3050**
 System: **Terminal & Package Units**
 Material: **Packaged A/C, Elec. Ht., Const. Volume**
 Distress: **Missing**
 Category: **Capital Improvement**
 Correction: **Install Package A/C - 20 ton**
 Note: **An air conditioning system is missing in the gymnasium and should be installed.**

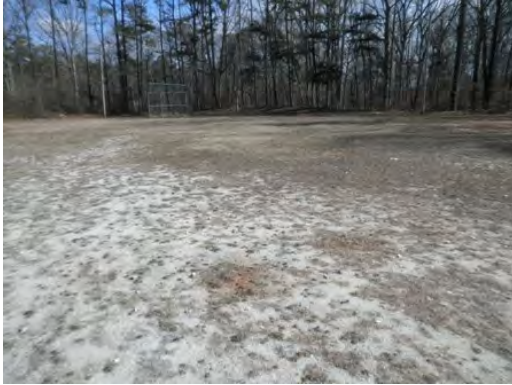
Assembly: **F1040**
 System: **Special Facilities - Sports Field - Natural Turf System**
 Material: **System**
 Distress: **Beyond Service Life**
 Category: **Deferred Maintenance**
 Correction: **Renew System**
 Note: **The play field turf is worn and should be reseeded.**

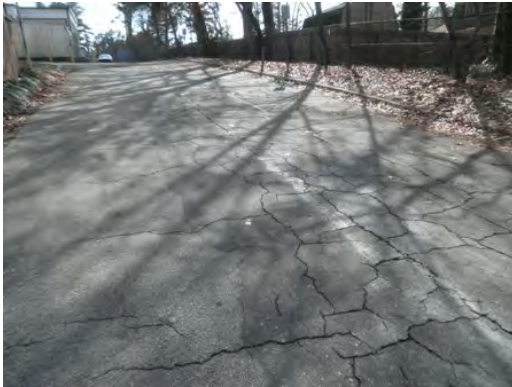
Assembly: **G2010**
System: **Roadways**
Material: **System**
Distress: **Beyond Service Life**
Category: **Deferred Maintenance**
Correction: **Renew System**
Note: **The roadways in front and in back of the main building are aged and worn beyond their service life. These areas should be repaved and restriped.**

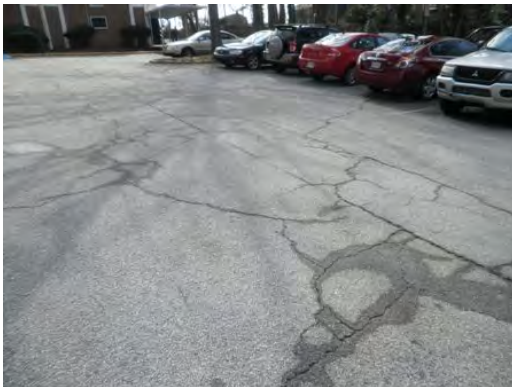
Assembly: **G2020**
System: **Parking Lots**
Material: **System**
Distress: **Beyond Service Life**
Category: **Deferred Maintenance**
Correction: **Renew System**
Note: **The parking lots are aged and cracked and should be resurfaced and restriped.**

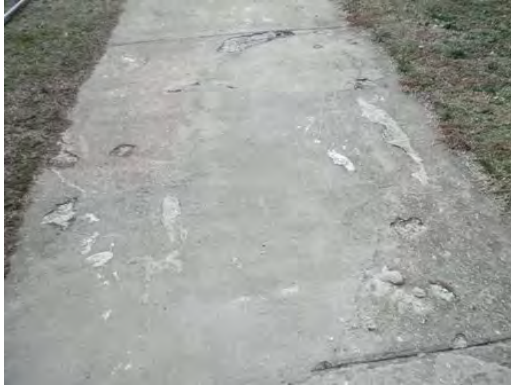
Note: **The sidewalks are aged, cracked, and damaged, and should be replaced.**

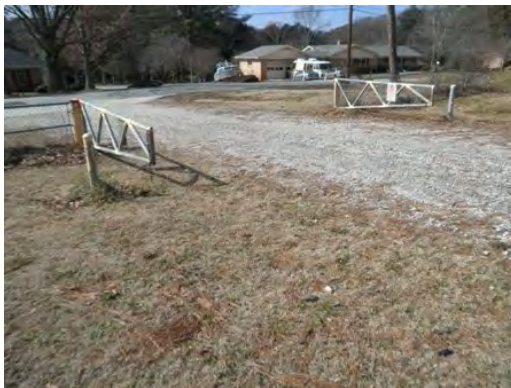
Note: **The fences and gates are broken, unable to lock, and should be scheduled for replacement.**

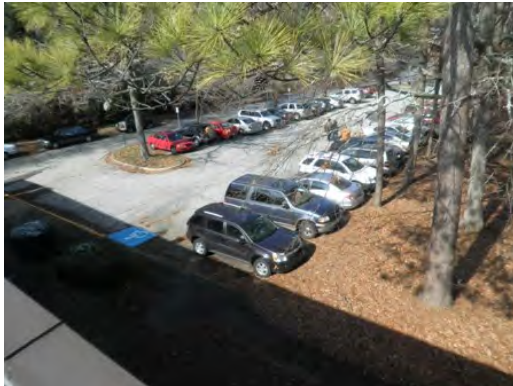
Assembly: **G4020**
System: **Site Lighting**
Material: **System**
Distress: **Beyond Service Life**
Category: **Deferred Maintenance**
Correction: **Renew System**
Note: **Site lighting for the parking areas is aged and inadequate and should be replaced.**
