Facility Condition Assessment Report

Stephenson Middle Facility Executive Summary ReportReport Date: 24 Jun 2011

Facility: \Middle Schools\Stephenson Middle**Address:** 922 Stephenson Road, Stone Mountain, GA 30087**Attributes:****Facility Code** 0397
Super Cluster 3**General Information:****Function:** Middle School
Gross Area: 190,323 S.F.**Year Built:**
Last Renovation:**Facility Description:**

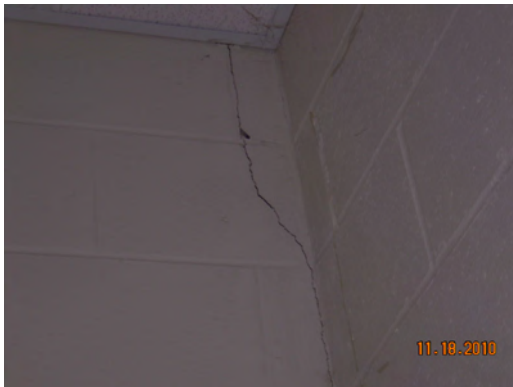
Assembly: **A1010**
System: **Standard Foundations**
Material: **Standard Foundations**
Distress: **Needs Remediation**
Category: **Safety**
Correction: **Professional Engineering Study**
Note: **Differential settlement was observed throughout the building and an engineering study is recommended to determine the cause. Pricing does not include remediation measures.**

Raw Cost	\$25,000.00
Plus or (Minus) Additional Cost	\$9,500.00
Total Estimated Amount	\$34,500.00

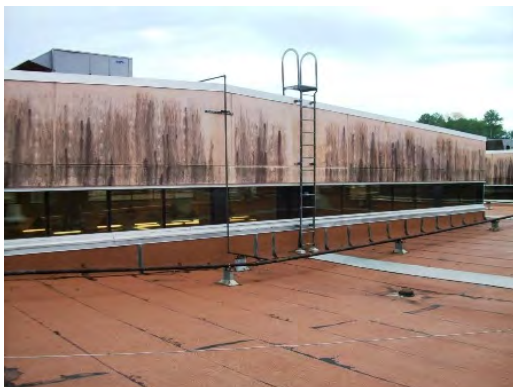
Assembly: **B2010**
System: **Exterior Walls**
Material: **Stucco Wall**
Distress: **Needs Remediation**
Category: **Deferred Maintenance**
Correction: **Repair Stucco Walls**
Note: **The stucco finish on the parapet is stained and damaged and should be replaced.**

Raw Cost	\$121,600.00
Plus or (Minus) Additional Cost	\$46,208.00
Total Estimated Amount	\$167,808.00

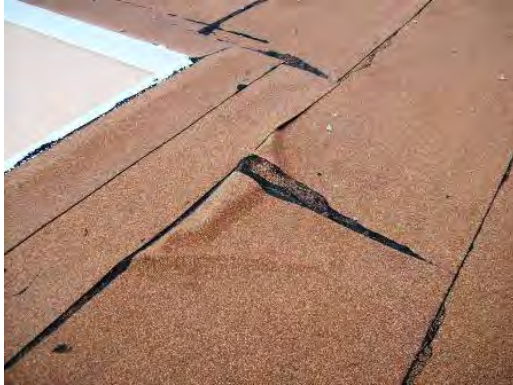
Assembly: **B3010**
System: **Roof Coverings - BUR**
Material: **System**
Distress: **Needs Remediation**
Category: **Deferred Maintenance**
Correction: **Renew System**
Note: **The original built-up roof covering is deteriorating and should be scheduled for replacement.**

Raw Cost	\$762,012.31
Plus or (Minus) Additional Cost	\$289,564.68
Total Estimated Amount	\$1,051,576.99

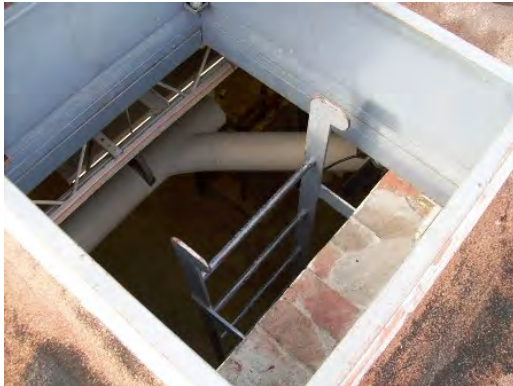
Assembly: **B3020**
System: **Roof Openings**
Material: **Roof Hatches, Skylights**
Distress: **Inadequate**
Category: **Code Compliance**
Correction: **Replace Roof Hatches, Skylights**
Note: **The stair for the roof hatch is not OSHA compliant, as it should extend beyond the hatch.**

Raw Cost	\$5,900.00
Plus or (Minus) Additional Cost	\$2,242.00
Total Estimated Amount	\$8,142.00

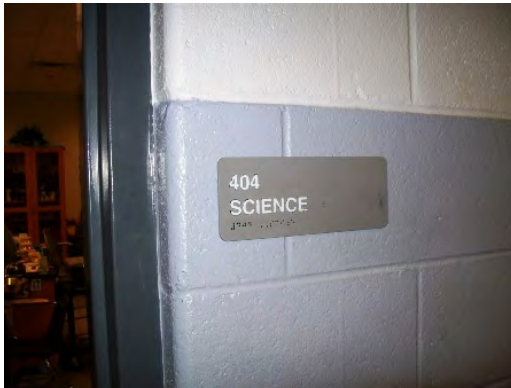
Assembly: **C1030**
 System: **Fittings**
 Material: **Identifying Devices**
 Distress: **Inadequate**
 Category: **Code Compliance**
 Correction: **Install room signage**

Note: **Room signage is inadequate and missing from many rooms, not mounted at the correct height, and lacks the necessary Braille markings.**

Raw Cost	\$21,460.00
Plus or (Minus) Additional Cost	\$8,154.80
Total Estimated Amount	\$29,614.80

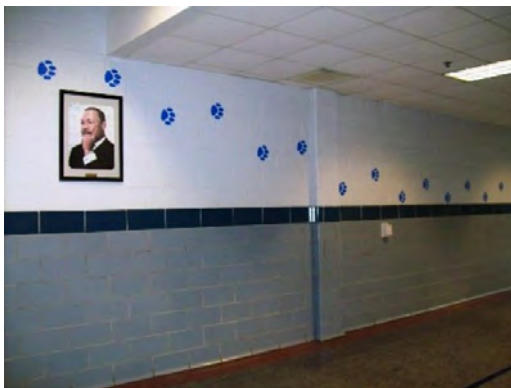
Note: **The painted wall finishes are worn and scuffed and should be repainted.**

Raw Cost	\$248,317.44
Plus or (Minus) Additional Cost	\$94,360.63
Total Estimated Amount	\$342,678.07

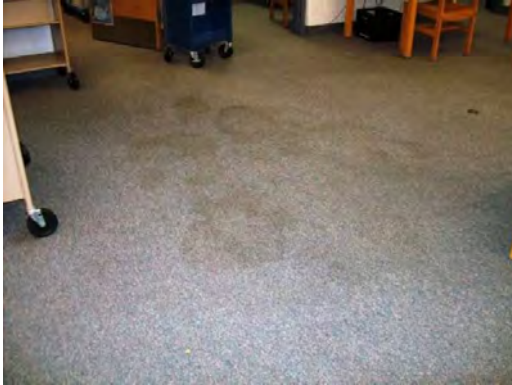
Assembly: **C3020**
 System: **Floor Finishes - Carpet**
 Material: **System**
 Distress: **Beyond Service Life**
 Category: **Deferred Maintenance**
 Correction: **Renew System**
 Note: **The carpet is aged, worn, and stained, and should be replaced.**

Raw Cost	\$21,606.42
Plus or (Minus) Additional Cost	\$8,210.44
Total Estimated Amount	\$29,816.86

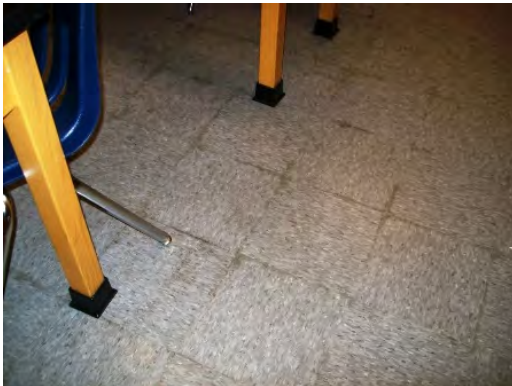
Assembly: **C3020**
 System: **Floor Finishes - VCT**
 Material: **System**
 Distress: **Needs Remediation**
 Category: **Deferred Maintenance**
 Correction: **Renew System**
 Note: **The vinyl floor finish is deteriorated and stained and should be replaced.**

Raw Cost	\$504,980.48
Plus or (Minus) Additional Cost	\$191,892.58
Total Estimated Amount	\$696,873.06

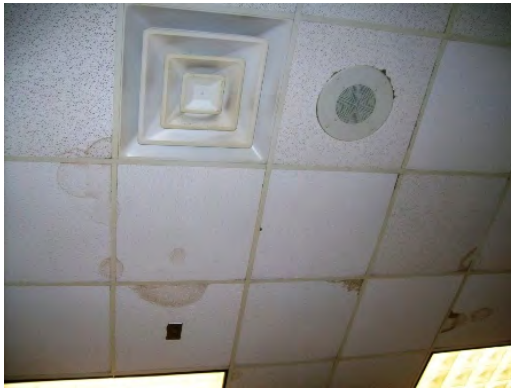
Assembly: **C3030**
 System: **Ceiling Finishes**
 Material: **Acoustical Ceilings**
 Distress: **Damaged**
 Category: **Deferred Maintenance**
 Correction: **Repair Acoustical Ceilings**

Note: **A portion of the acoustical ceiling system is stained and deteriorated due to the damaged roof and should be replaced.**

Raw Cost	\$74,442.24
Plus or (Minus) Additional Cost	\$28,288.05
Total Estimated Amount	\$102,730.29

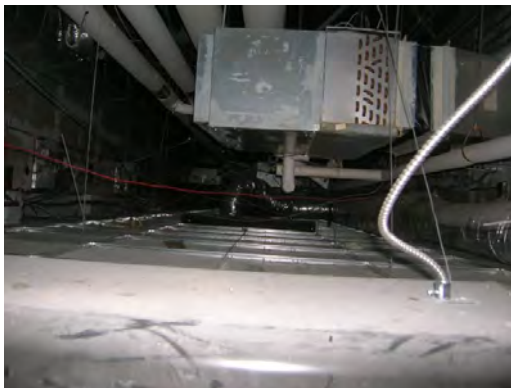
Note: **The original water source heat pumps are aged, worn, becoming logistically unsupportable, and should be replaced.**

Raw Cost	\$1,719,266.57
Plus or (Minus) Additional Cost	\$653,321.30
Total Estimated Amount	\$2,372,587.87

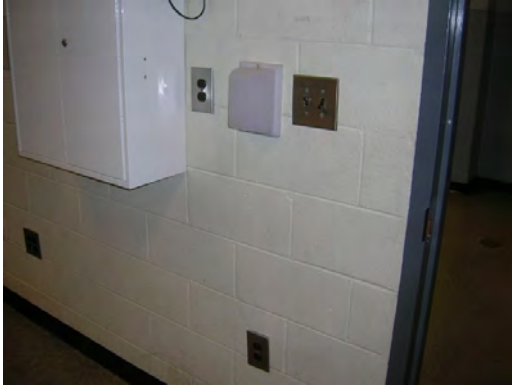
Note: The environmental control system is aged and should be replaced.

Raw Cost	\$439,768.30
Plus or (Minus) Additional Cost	\$167,111.95
Total Estimated Amount	\$606,880.25

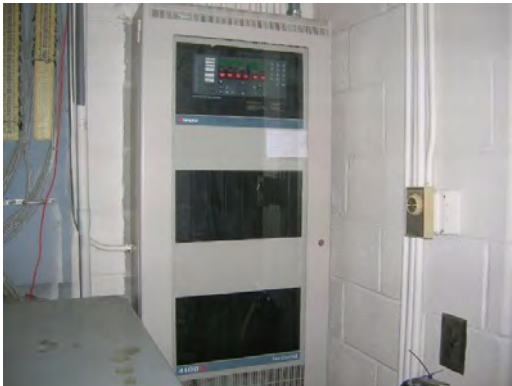
Note: The original fire alarm system is operable, but is aged and should be scheduled for replacement.

Raw Cost	\$193,346.41
Plus or (Minus) Additional Cost	\$73,471.63
Total Estimated Amount	\$266,818.04

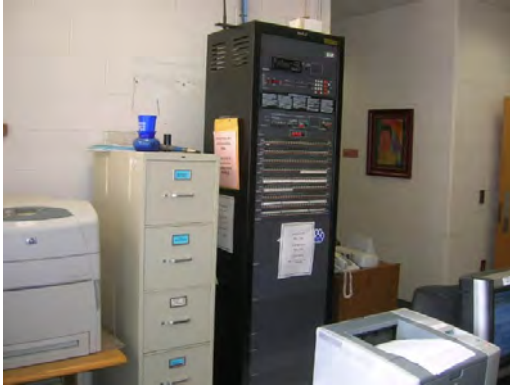
Material: **System**
 Distress: **Beyond Service Life**
 Category: **Deferred Maintenance**
 Correction: **Renew System**

Note: **The original PA and clock systems are operable, but aged and should be scheduled for replacement.**

Raw Cost	\$447,350.51
Plus or (Minus) Additional Cost	\$169,993.19
Total Estimated Amount	\$617,343.70

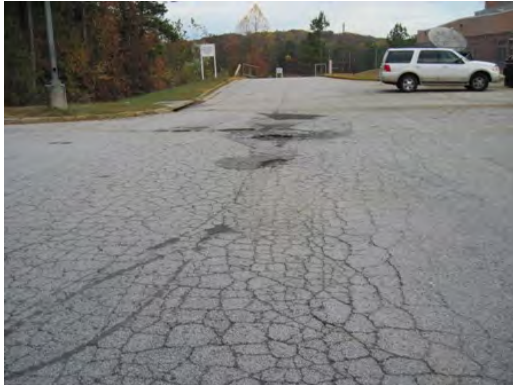
Assembly: **G2020**
 System: **Parking Lots**
 Material: **Paving**
 Distress: **Damaged**
 Category: **Deferred Maintenance**
 Correction: **Re-pave parking lot / roadways**
 Note: **A portion of the parking lot is cracked and damaged and should be repaved.**

Raw Cost	\$128,200.00
	Plus or (Minus) Additional Cost	\$33,332.00
	Total Estimated Amount	\$161,532.00

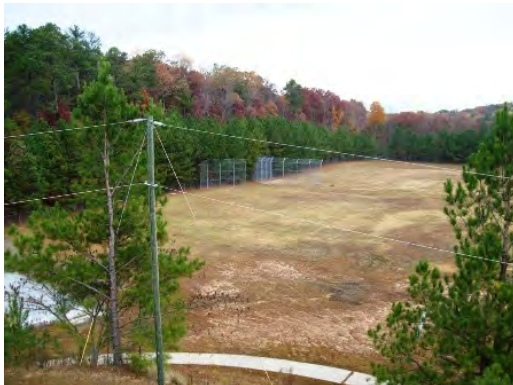
Assembly: **G2050**
 System: **Landscaping**
 Material: **System**
 Distress: **Inadequate**
 Category: **Deferred Maintenance**
 Correction: **Renew System**
 Note: **The site is in need of reseeding, especially at the play ground areas.**

Raw Cost	\$20,174.24
	Plus or (Minus) Additional Cost	\$5,245.30
	Total Estimated Amount	\$25,419.54

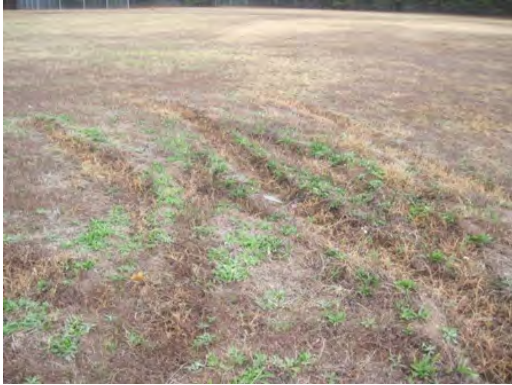
Assembly: **F1040**
System: **Special Facilities - Sports Field - Natural Turf System**
Material: **Damaged**
Distress: **Damaged**
Category: **Deferred Maintenance**
Correction: **Renew System**
Note: **The playfield is damaged and aged and should be reseeded.**

Raw Cost	\$3,234.00
Plus or (Minus) Additional Cost	\$840.84
Total Estimated Amount	\$4,074.84

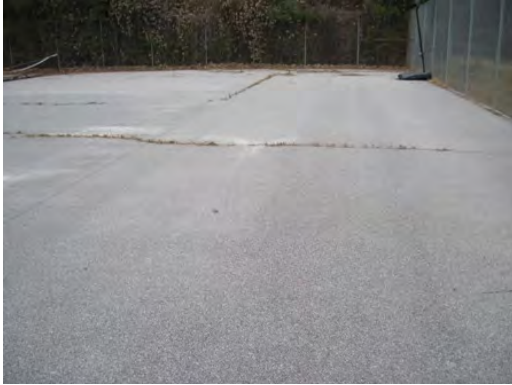
Assembly: **F1040**
System: **Special Facilities - Tennis Court Hard Surface System**
Material: **System**
Distress: **Damaged**
Category: **Deferred Maintenance**
Correction: **Renew System**
Note: **The existing hardcourt surface is cracked and damaged and should be resurfaced.**

Raw Cost	\$155,015.52
Plus or (Minus) Additional Cost	\$40,304.04
Total Estimated Amount	\$195,319.56

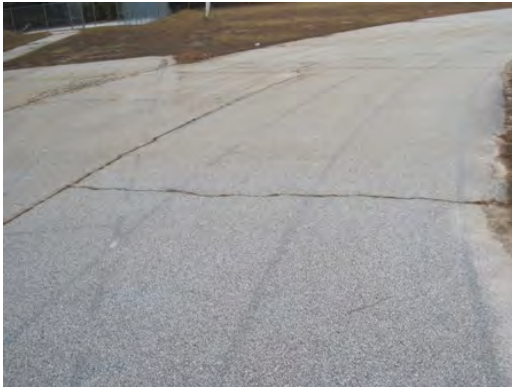
Assembly: **F1040**
System: **Special Facilities - Running Track Surface & Curbing System**
Material: **Damaged**
Distress: **Deferred Maintenance**
Category: **Renew System**
Correction: **The track surface is cracked and damaged throughout and should be resurfaced.**

The school track is in poor condition.

Raw Cost	\$300,606.46
Plus or (Minus) Additional Cost	\$78,157.68
Total Estimated Amount	\$378,764.14
