Facility Condition Assessment Report

DeKalb County School System1701 Mountain Industrial Blvd
Stone Mountain, GA 30083COMET4 Facility Report
William Bradley Bryant Center Facility Executive Summary ReportReport Date: 24 Jun 2011

Facility: \Non School Sites\William Bradley Bryant Center
Address: 2652 Lawrenceville Hwy, Decatur, GA 30032**Attributes:****Facility Code** 0308
Super Cluster 0**General Information:****Function:** Non School Sites
Gross Area: 41,041 S.F. **Year Built:**
Last Renovation:**Facility Description:**

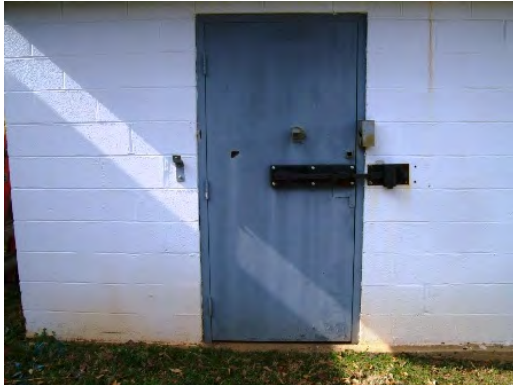
Note: **The original metal exterior doors are aged and rusted and should be replaced.**

Raw Cost	\$596.75
Plus or (Minus) Additional Cost	\$226.76
Total Estimated Amount	\$823.51

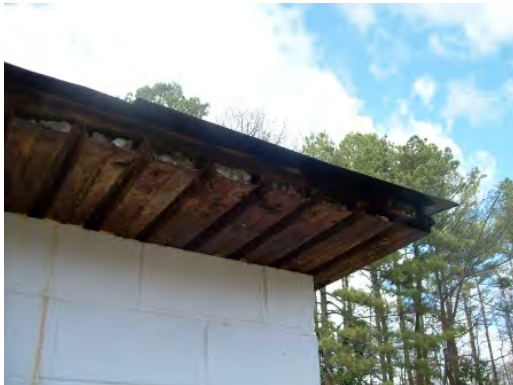
Note: **The built-up roofing is aged and worn and should be replaced.**

Raw Cost	\$1,774.91
Plus or (Minus) Additional Cost	\$674.46
Total Estimated Amount	\$2,449.37

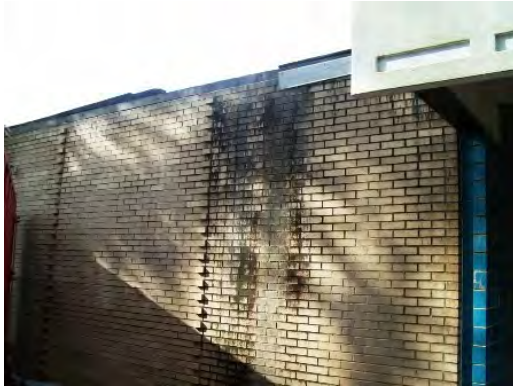
Assembly: **B2010**
System: **Exterior Walls**
Material: **Brick Face Cavity Wall**
Distress: **Beyond Service Life**
Category: **Deferred Maintenance**
Correction: **Power wash brick face cavity wall**
Note: **The exterior walls are stained and need to be pressure washed.**

Raw Cost	\$17,895.00
Plus or (Minus) Additional Cost	\$6,800.10
Total Estimated Amount	\$24,695.10

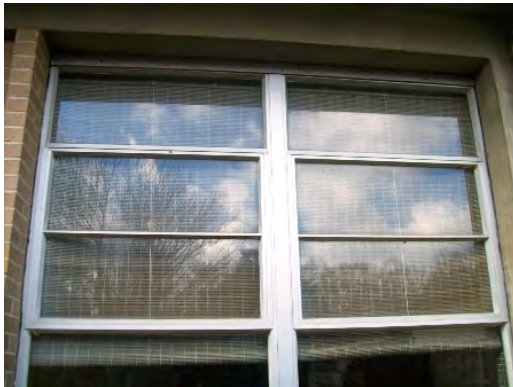
Assembly: **B2020**
System: **Exterior Windows**
Material: **System**
Distress: **Beyond Service Life**
Category: **Deferred Maintenance**
Correction: **Renew System**
Note: **The original metal frame, single pane, operable windows are aged, worn, and inefficient, and should be replaced.**

Raw Cost	\$177,420.24
Plus or (Minus) Additional Cost	\$67,419.69
Total Estimated Amount	\$244,839.93

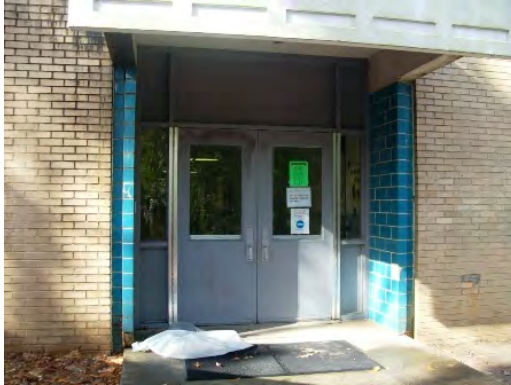
Note: **The original metal exterior doors are aged and rusted and should be replaced with energy efficient doors.**

Raw Cost	\$42,887.85
Plus or (Minus) Additional Cost	\$16,297.38
Total Estimated Amount	\$59,185.23

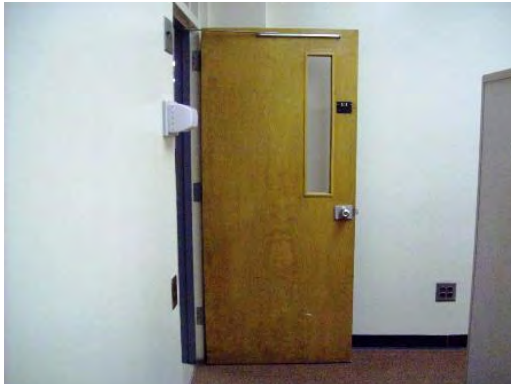
Note: **While approximately 25% of the system will be renewed in 2011 as part of the Data Center and Technology Department renovations, the remaining 75% of the wood interior doors are aged and worn and should be replaced.**

Raw Cost	\$239,269.03
Plus or (Minus) Additional Cost	\$90,922.23
Total Estimated Amount	\$330,191.26

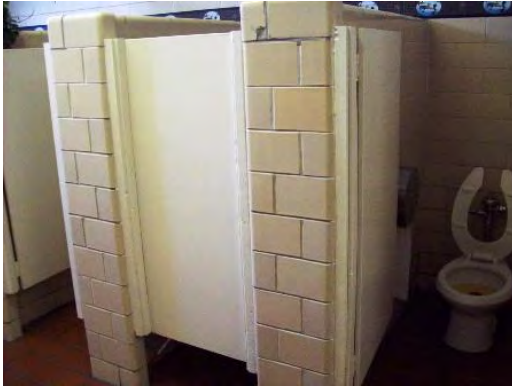
While approximately 25% of the system will be renewed in 2011 as part of the Data Center and Technology Department renovations, the remaining 75% of the fittings, such as chalk and tack boards, lockers, toilet and bath accessories, toilet partitions, and shelving, are beyond their service life and should be replaced.

Raw Cost	\$46,499.45
Plus or (Minus) Additional Cost	\$17,669.79
Total Estimated Amount	\$64,169.24

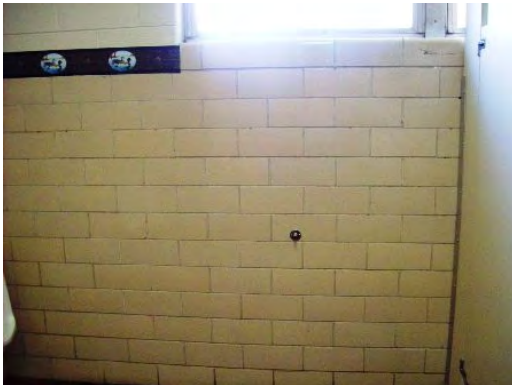
While approximately 25% of the system will be renewed in 2011 as part of the Data Center and Technology Department renovations, the remaining 75% of the glazed tile wall covering is aged and should be replaced.

Raw Cost	\$104,433.12
Plus or (Minus) Additional Cost	\$39,684.59
Total Estimated Amount	\$144,117.71

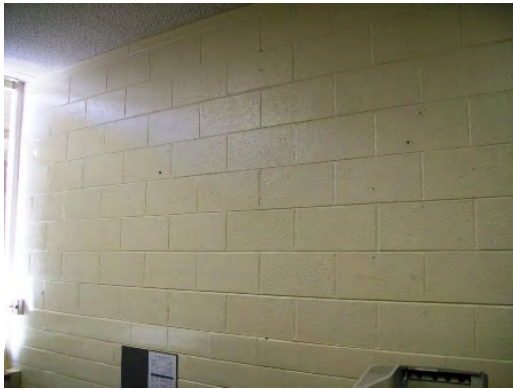
Note: **While approximately 25% of the system will be renewed in 2011 as part of the Data Center and Technology Department renovations, the remaining 75% of the wall paint is aged and scuffed and should be repainted.**

Raw Cost	\$39,427.20
Plus or (Minus) Additional Cost	\$14,982.34
Total Estimated Amount	\$54,409.54

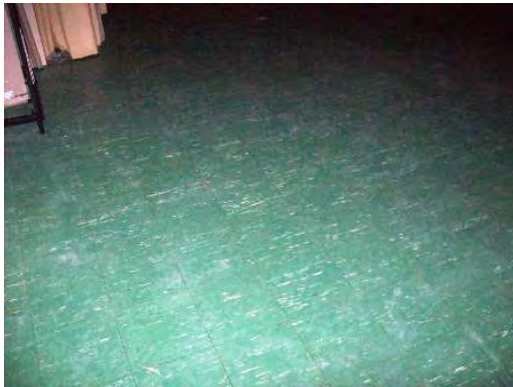
Note: **While approximately 25% of the system will be renewed in 2011 as part of the Data Center and Technology Department renovations, the remaining 75% of the VCT flooring is aged, faded, and patched, and should be replaced.**

Raw Cost	\$115,026.91
Plus or (Minus) Additional Cost	\$43,710.23
Total Estimated Amount	\$158,737.14

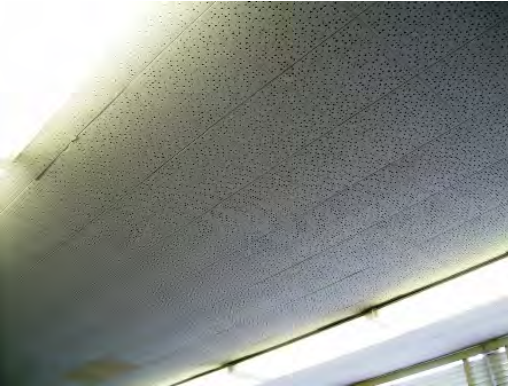
While approximately 25% of the system will be renewed in 2011 as part of the Data Center and Technology Department renovations, the remaining 75% of the acoustical ceiling tile and grid system is aged and stained should be replaced.

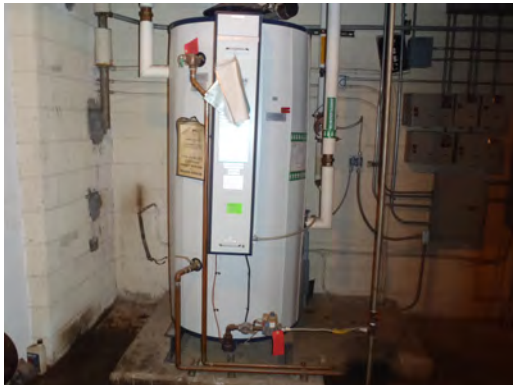
While approximately 25% of the system will be renewed in 2011 as part of the Data Center and Technology Department renovations, the remaining 75% of the domestic water system is aged and should be replaced.

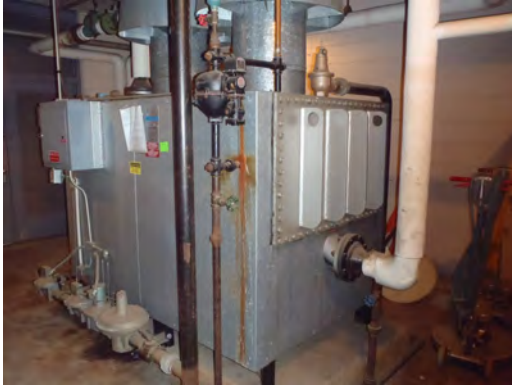
Note: **While approximately 25% of the system will be renewed in 2011 as part of the Data Center and Technology Department renovations, the remaining 75% of the heating system is aged and should be replaced.**

Raw Cost	\$135,886.75
Plus or (Minus) Additional Cost	\$51,636.97
Total Estimated Amount	\$187,523.72

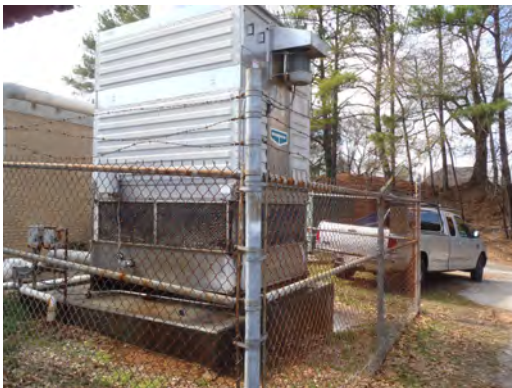
Note: **While approximately 25% of the system will be renewed in 2011 as part of the Data Center and Technology Department renovations, the remaining 75% of cooling system is aged and should be replaced.**

Raw Cost	\$138,144.01
Plus or (Minus) Additional Cost	\$52,494.72
Total Estimated Amount	\$190,638.73

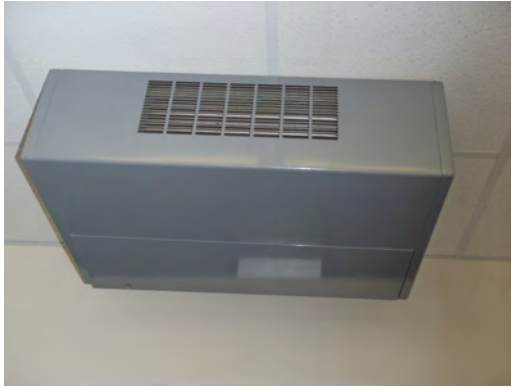
Note: **While approximately 25% of the system will be renewed in 2011 as part of the Data Center and Technology Department renovations, the remaining 75% of the air distribution and exhaust system is aged and should be replaced.**

Raw Cost	\$152,590.44
Plus or (Minus) Additional Cost	\$57,984.37
Total Estimated Amount	\$210,574.81

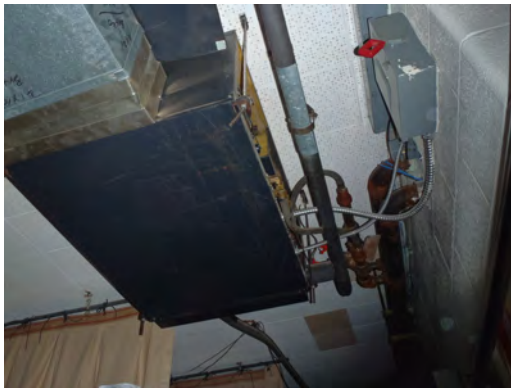
Note: **While approximately 25% of the system will be renewed in 2011 as part of the Data Center and Technology Department renovations, the remaining 75% of the heat pumps, RTUs and fan coil units are aged and should be replaced.**

Raw Cost	\$565,668.10
Plus or (Minus) Additional Cost	\$214,953.88
Total Estimated Amount	\$780,621.98

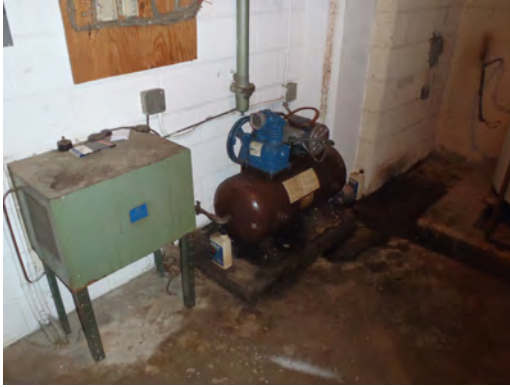
Note: **While approximately 25% of the system will be renewed in 2011 as part of the Data Center and Technology Department renovations, the remaining 75% of the HVAC control system is aged and should be replaced.**

Raw Cost	\$104,736.63
Plus or (Minus) Additional Cost	\$39,799.92
Total Estimated Amount	\$144,536.55

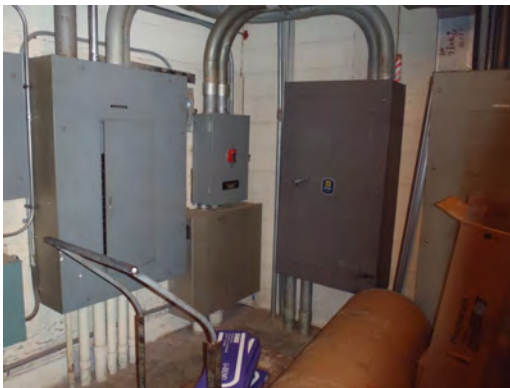
Note: **While approximately 25% of the system will be renewed in 2011 as part of the Data Center and Technology Department renovations, the remaining 75% of the branch wiring is aged and inadequate and should be replaced.**

Raw Cost	\$211,730.52
Plus or (Minus) Additional Cost	\$80,457.60
Total Estimated Amount	\$292,188.12

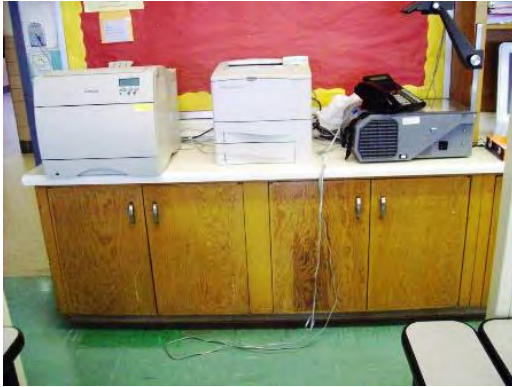
While approximately 25% of the system will be renewed in 2011 as part of the Data Center and Technology Department renovations, the remaining 75% of the fixed furnishings, such as the base/wall cabinets, counter tops, window shades, and fixed seating, are worn, beyond their service life, and should be replaced.

Raw Cost	\$168,842.67
Plus or (Minus) Additional Cost	\$64,160.22
Total Estimated Amount	\$233,002.89

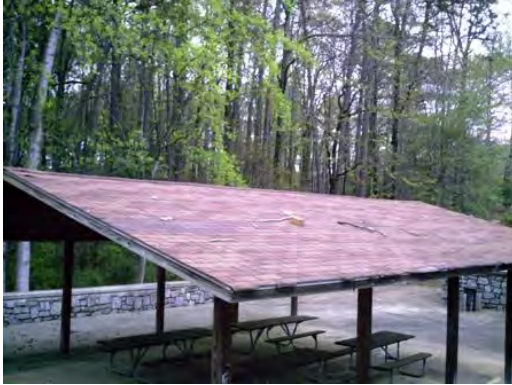
Assembly: **B3010**
System: **Roof Coverings**
Material: **System**
Distress: **Beyond Service Life**
Category: **Deferred Maintenance**
Correction: **Renew System**
Note: **The built-up roof covering is aged and worn and should be replaced.**

Raw Cost	\$11,221.98
Plus or (Minus) Additional Cost	\$4,264.35
Total Estimated Amount	\$15,486.33

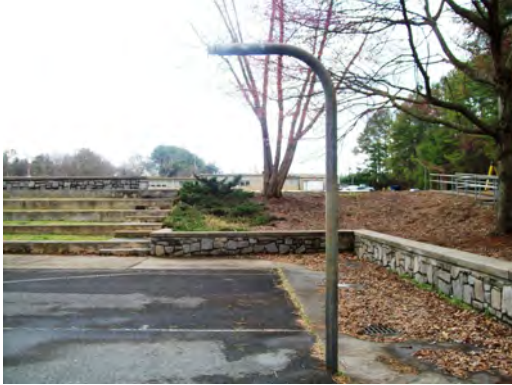
Assembly: **E1090**
System: **Other Equipment**
Material: **System**
Distress: **Beyond Service Life**
Category: **Deferred Maintenance**
Correction: **Renew System**
Note: **The athletic equipment is in poor condition and should be replaced.**

Raw Cost	\$6,142.66
Plus or (Minus) Additional Cost	\$1,597.09
Total Estimated Amount	\$7,739.75

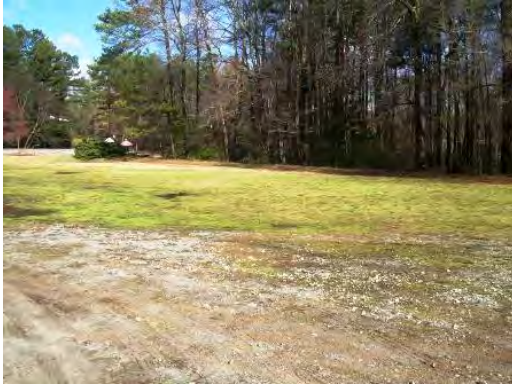
Assembly: **F1040**
System: **Special Facilities - Sports Field - Natural Turf System**
Material: **System**
Distress: **Beyond Service Life**
Category: **Deferred Maintenance**
Correction: **Renew System**
Note: **The grass is damaged and should be reseeded.**

Raw Cost	\$14,300.00
Plus or (Minus) Additional Cost	\$3,718.00
Total Estimated Amount	\$18,018.00

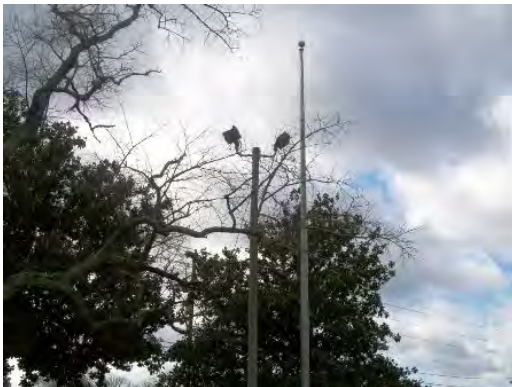
Assembly: **G2040**
System: **Site Development**
Material: **System**
Distress: **Beyond Service Life**
Category: **Deferred Maintenance**
Correction: **Renew System**
Note: **Site development features, such as the flagpole, site furnishing, and signage, are beyond their service life and should be replaced.**

Raw Cost	\$9,480.47
Plus or (Minus) Additional Cost	\$2,464.92
Total Estimated Amount	\$11,945.39

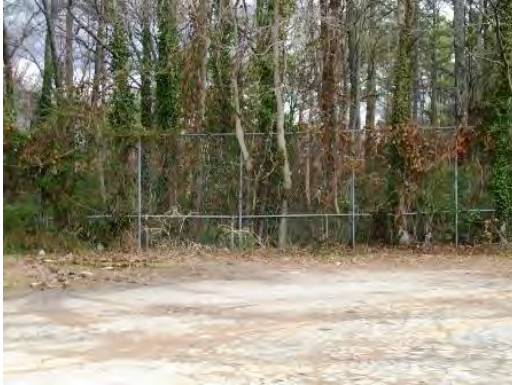
Assembly: **G2040105**
System: **Fence & Guardrails System**
Material: **System**
Distress: **Beyond Service Life**
Category: **Deferred Maintenance**
Correction: **Renew System**
Note: **The fencing is aged and damaged and should be replaced.**

Raw Cost	\$69,359.29
Plus or (Minus) Additional Cost	\$18,033.42
Total Estimated Amount	\$87,392.71

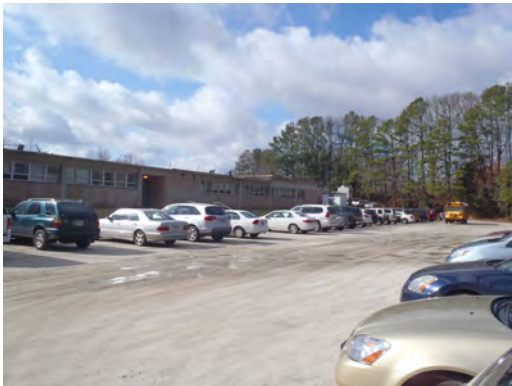
Assembly: **G4020**
System: **Site Lighting System**
Material: **System**
Distress: **Beyond Service Life**
Category: **Deferred Maintenance**
Correction: **Renew System**
Note: **Exterior lighting is aged and should be replaced.**

Raw Cost	\$24,829.81
Plus or (Minus) Additional Cost	\$6,455.75
Total Estimated Amount	\$31,285.56
