**DeKalb County School District/Elementary Schools**

# **Columbia Elementary**

## **School Assessment Report**

**May 19, 2016**

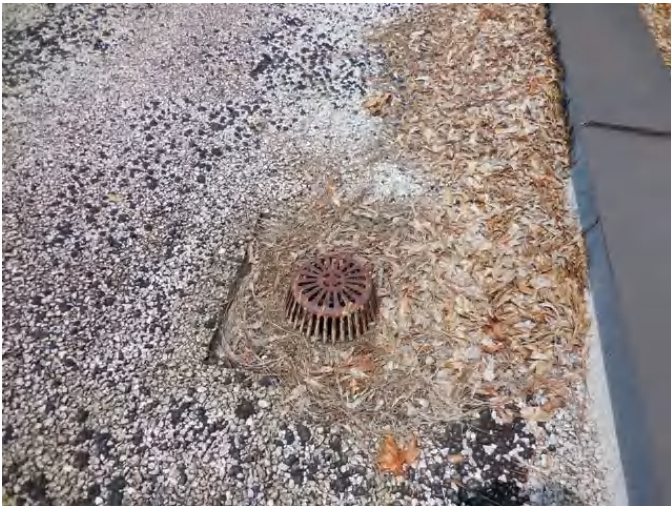
**System: D2040 - Rain Water Drainage**

**Location:** Throughout Building

**Distress:** Beyond Service Life

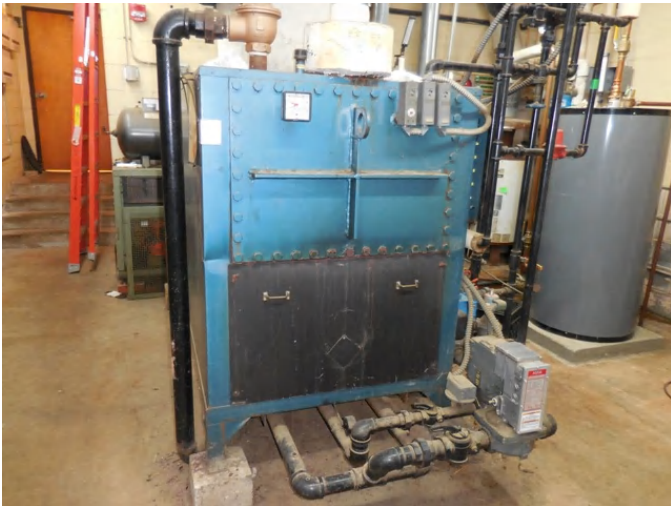
**System: D3020 - Heat Generating Systems**

**Location:** Mechanical Room

**Distress:** Beyond Service Life

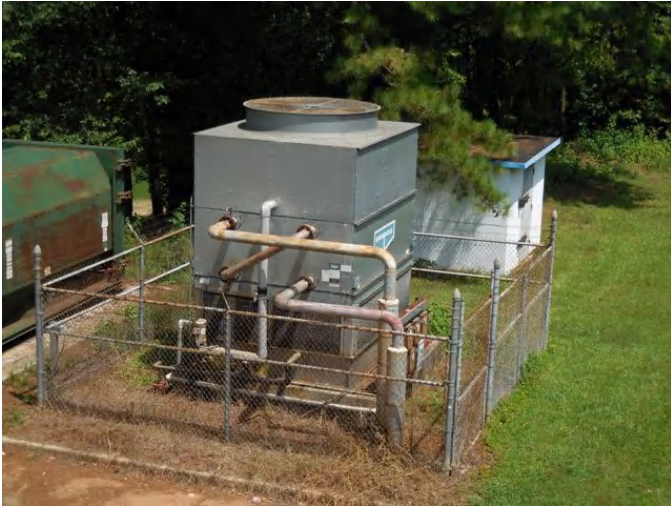
**System: D3030 - Cooling Generating Systems**

**Location:** Exterior of Building

**Distress:** Beyond Service Life

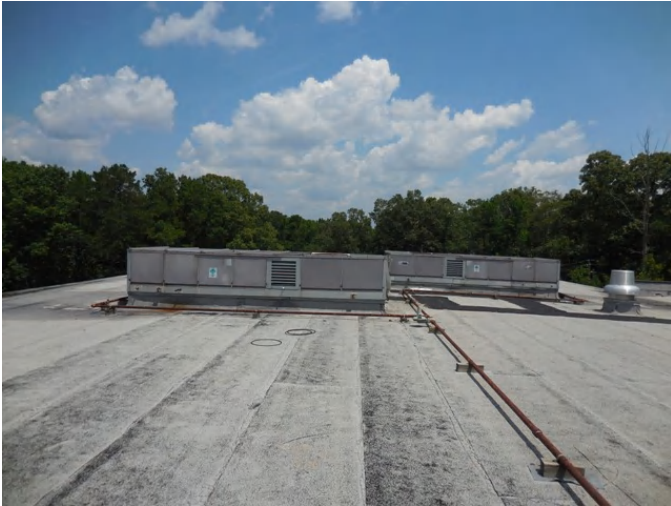
**System: D3050 - Terminal & Package Units**

**Location:** Roof

**Distress:** Needs Remediation

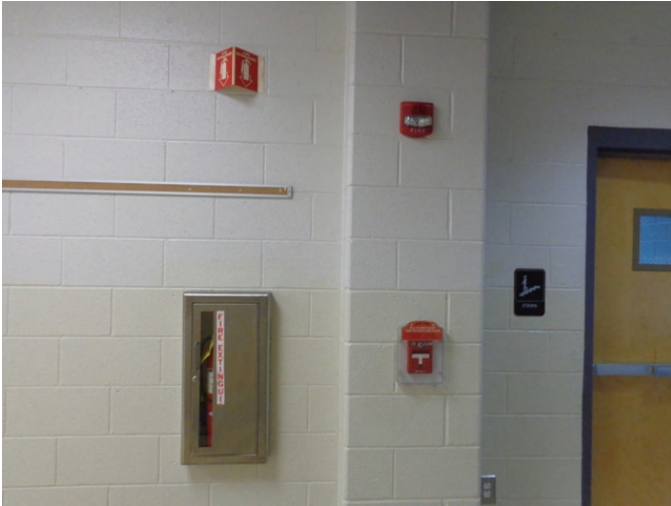
**System: D5030 - Communications and Security - Fire Alarm**

**Location:** Throughout Building

**Distress:** Beyond Service Life

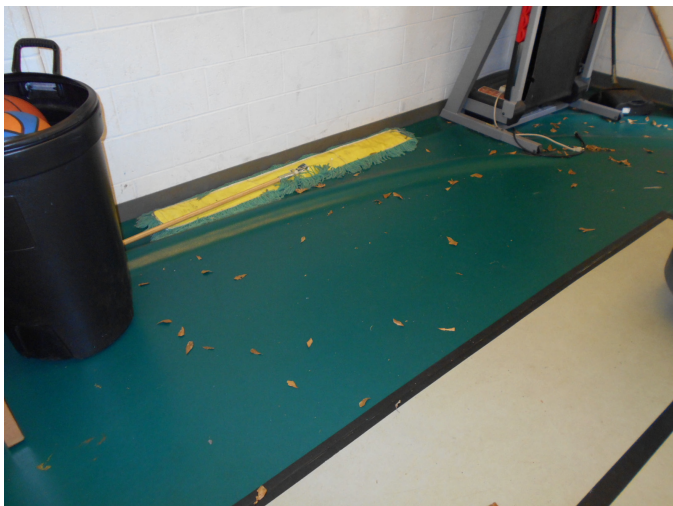
**System: C3020 - Floor Finishes - Neoprene**

**Location:** Basketball Court

**Distress:** Beyond Service Life

**Notes:** The athletic floor covering is beyond its expected service life, damaged, and should be replaced.

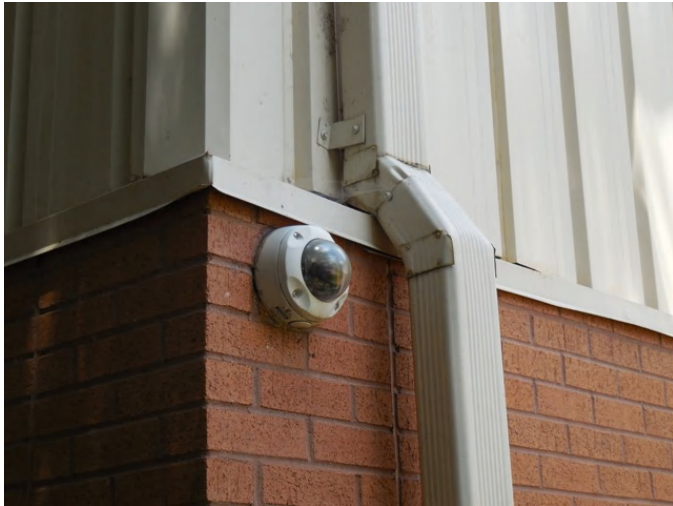
**System: D5030 - Communications and Security - Security & CCTV**

**Location:** Throughout Building

**Distress:** Beyond Service Life

**Notes:** The security and CCTV systems are original, beyond their expected service life and should be replaced/upgraded.

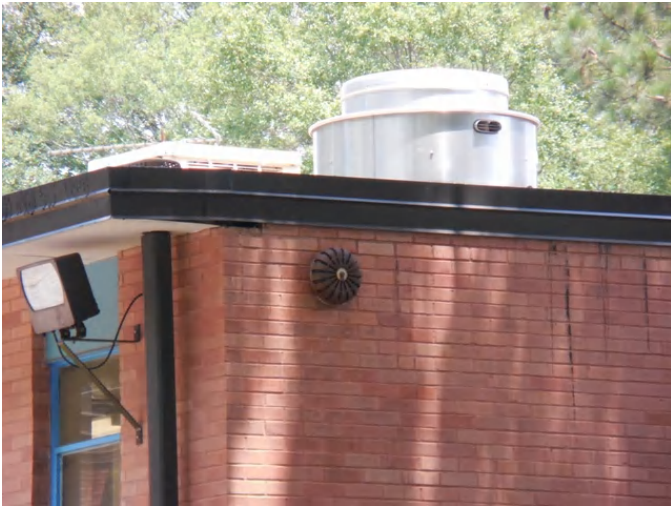
#### System: G4020 - Site Lighting

**Location:** Site

**Distress:** Beyond Service Life

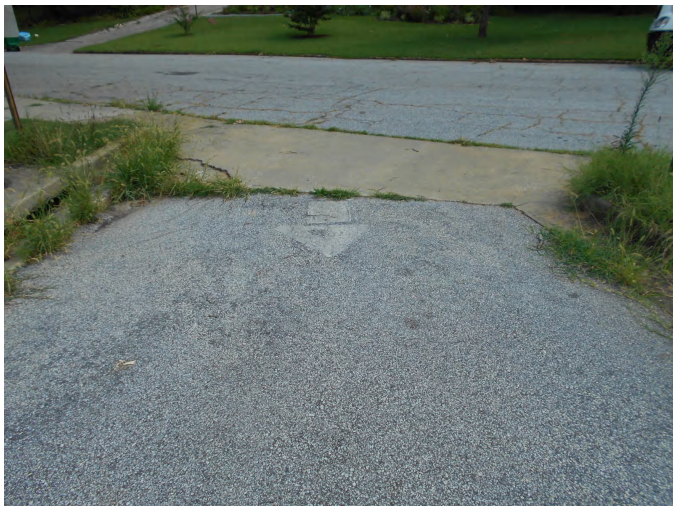
**System: G2010 - Roadways**

**Location:** Site

**Distress:** Beyond Service Life

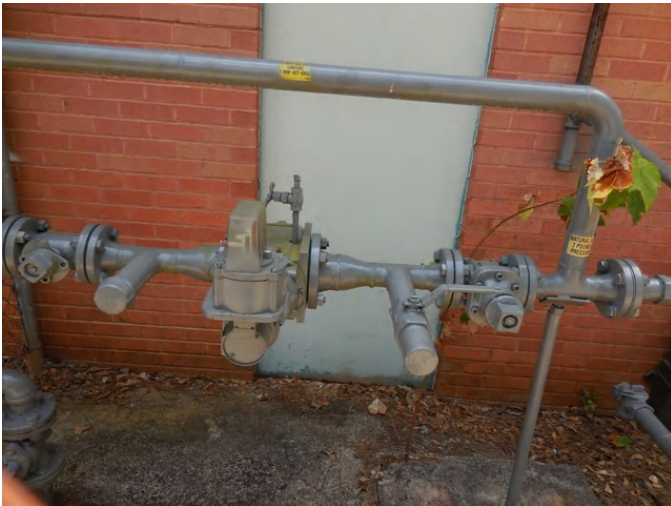
### **System: G3060 - Fuel Distribution**

**Location:** Site

**Distress:** Beyond Service Life
