DeKalb County School District/Vacant

# Former Central Office Building A and B

## School Assessment Report

May 20, 2016

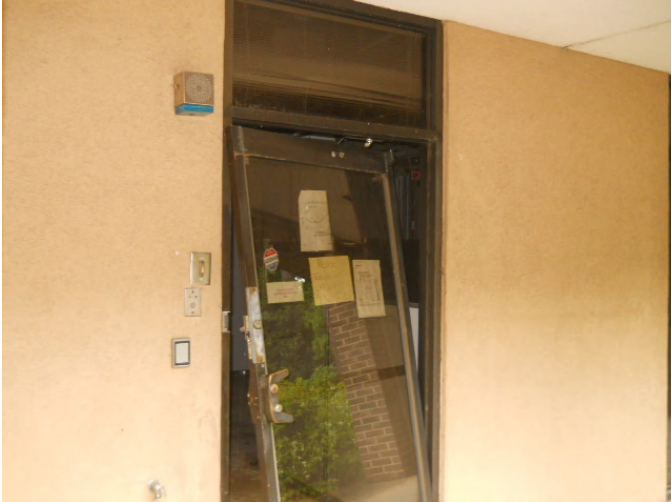
**System: B2030 - Exterior Doors**

**Location:** Exterior Walls

**Distress:** Beyond Service Life

**Notes:** The exterior doors are beyond their expected service life, damaged due to vandalism, not ADA compliant, not energy efficient, and should be replaced.

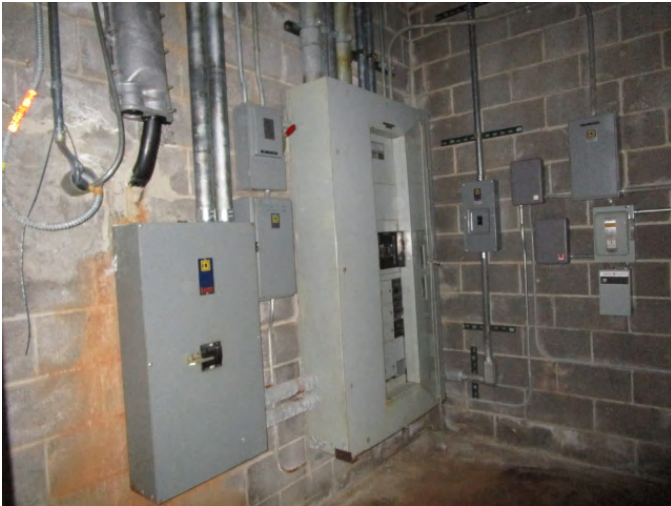
#### System: D5010 - Electrical Service/Distribution

**Location:** Throughout Building

**Distress:** Beyond Service Life

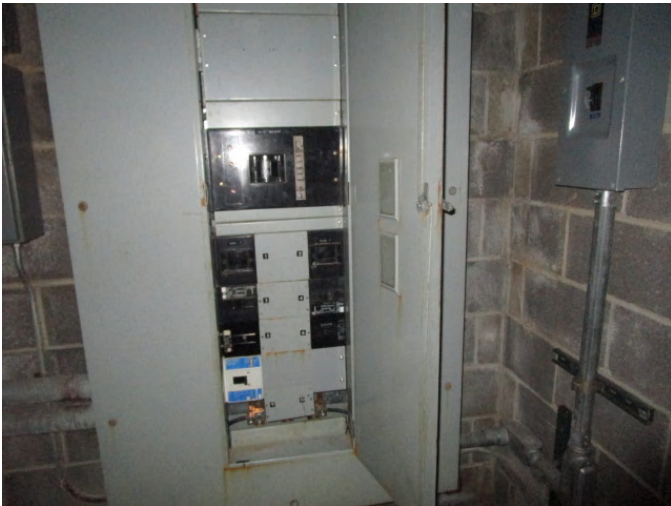
#### System: D5020 - Branch Wiring

**Location:** Throughout Building

**Distress:** Beyond Service Life

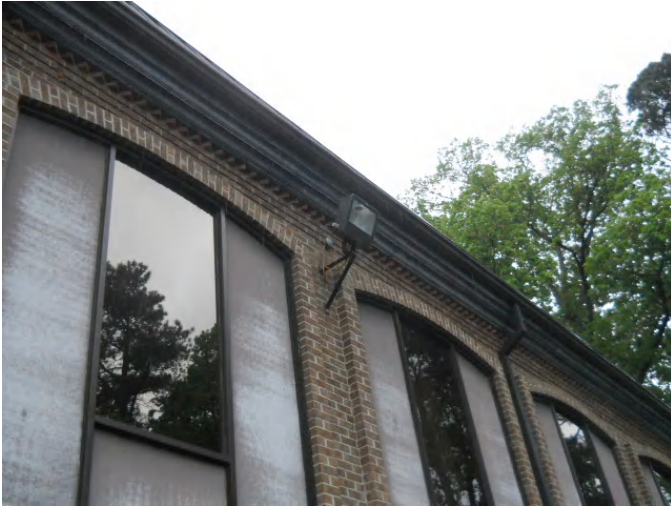
**System: B2020 - Exterior Windows**

**Location:** Throughout Building

**Distress:** Beyond Service Life

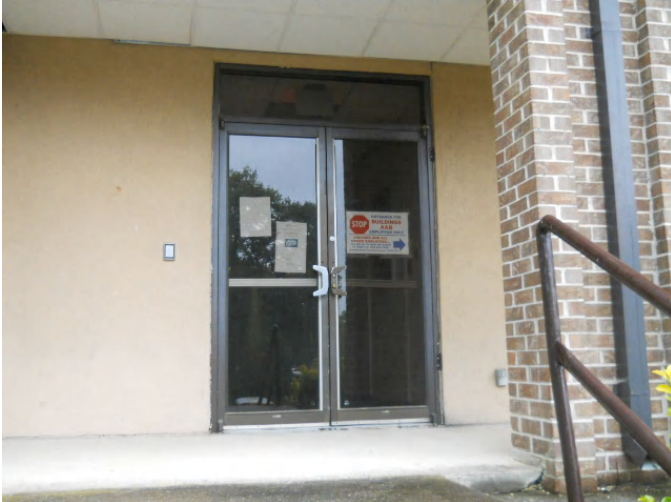
**System: B2030 - Exterior Doors**

**Location:** Throughout Building

**Distress:** Beyond Service Life

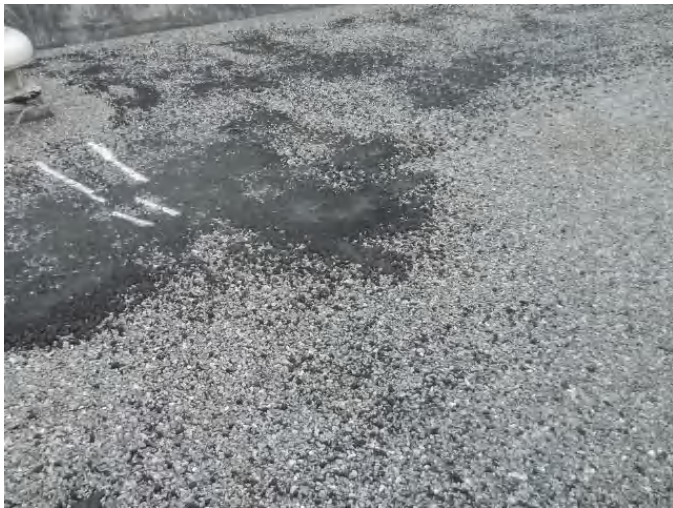
**System: B3010 - Roof Coverings - BUR**

**Location:** Roof

**Distress:** Beyond Service Life

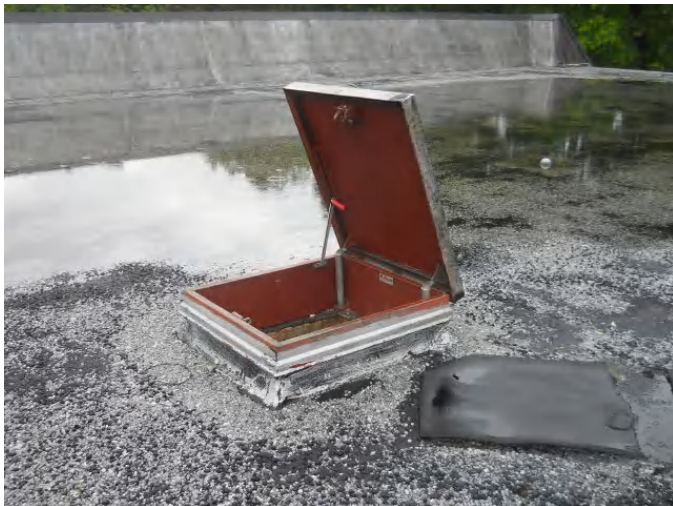
**System: B3020 - Roof Openings**

**Location:** Roof

**Distress:** Beyond Service Life

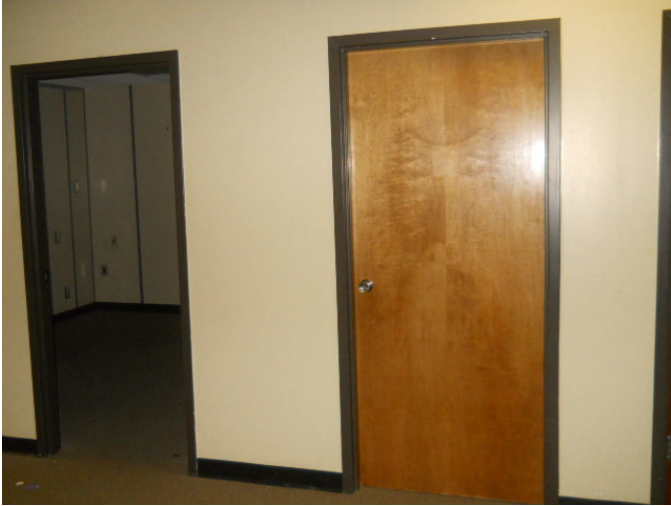
**System: C1020 - Interior Doors**

**Location:** Throughout Building

**Distress:** Beyond Service Life

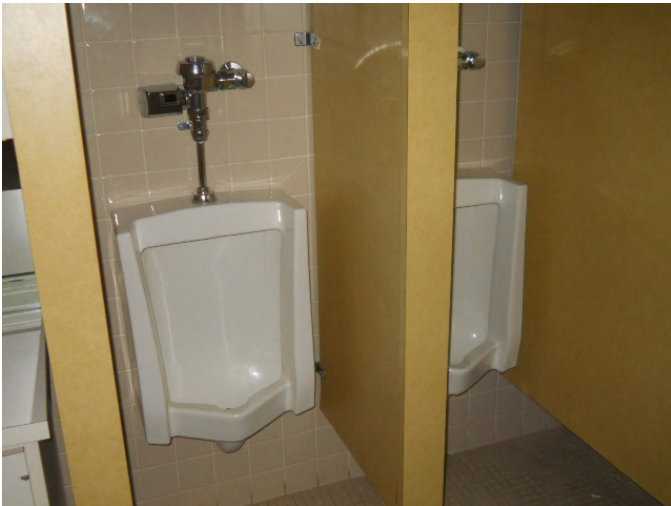
**System: C1030 - Fittings**

**Location:** Throughout Building

**Distress:** Beyond Service Life

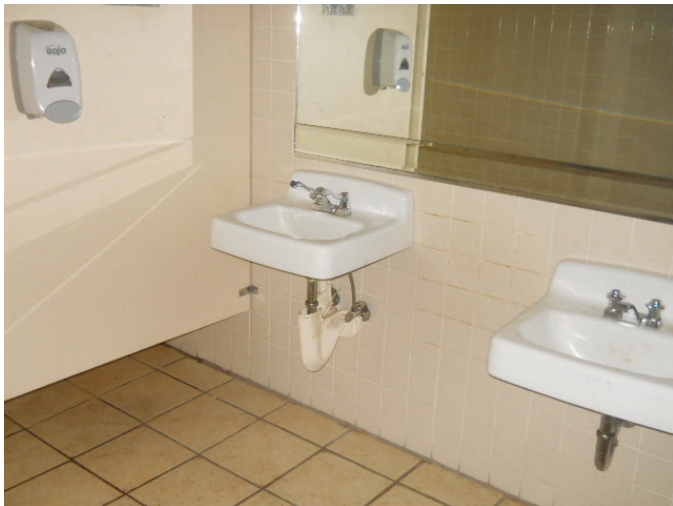
**System: C3010 - Wall Finishes - Ceramic & Glazed**

**Location:** Restrooms

**Distress:** Beyond Service Life

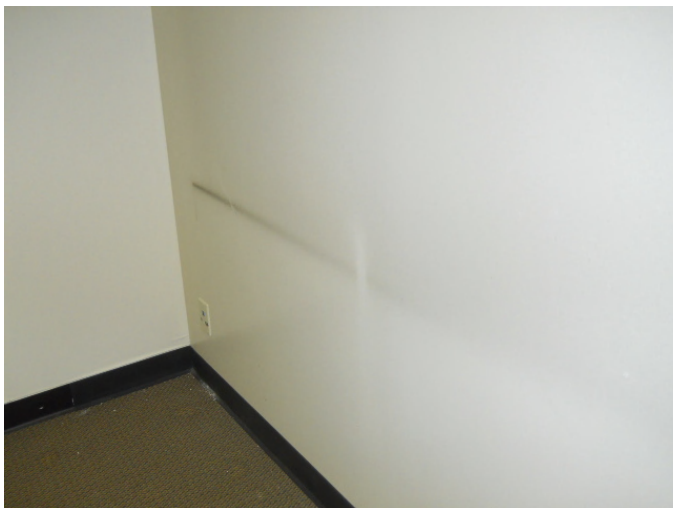
**System: C3010 - Wall Finishes - Paint**

**Location:** Throughout Building

**Distress:** Beyond Service Life

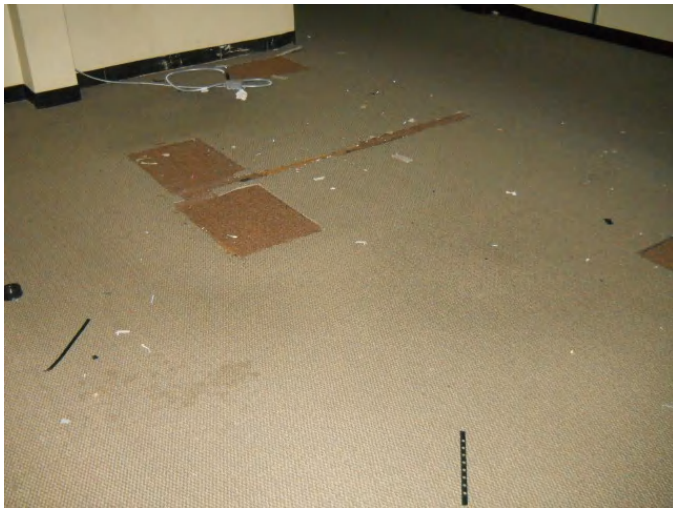
**System: C3020 - Floor Finishes - Carpet**

**Location:** Throughout Building

**Distress:** Beyond Service Life

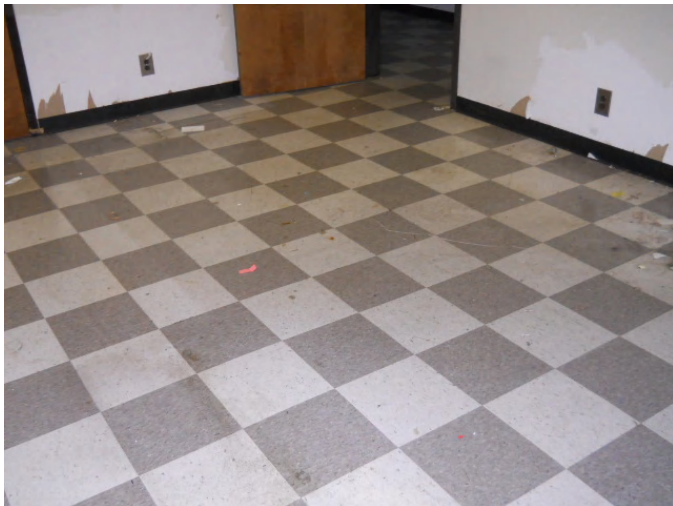
**System: C3020 - Floor Finishes - VCT**

**Location:** Throughout Building

**Distress:** Beyond Service Life

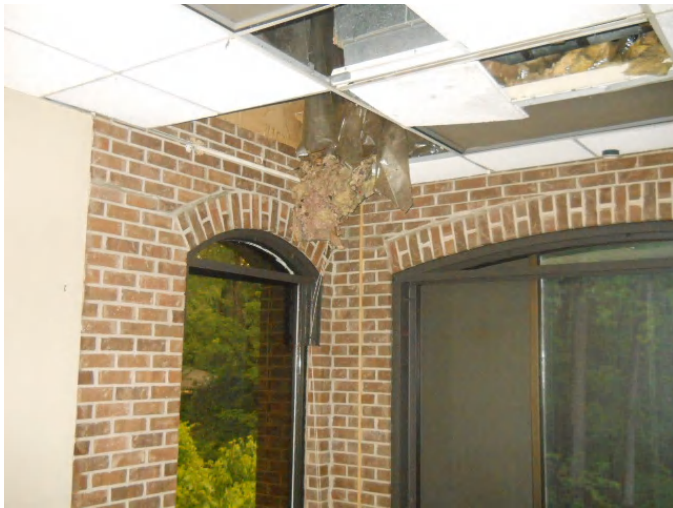
**System: C3030 - Ceiling Finishes**

**Location:** Throughout Building

**Distress:** Beyond Service Life

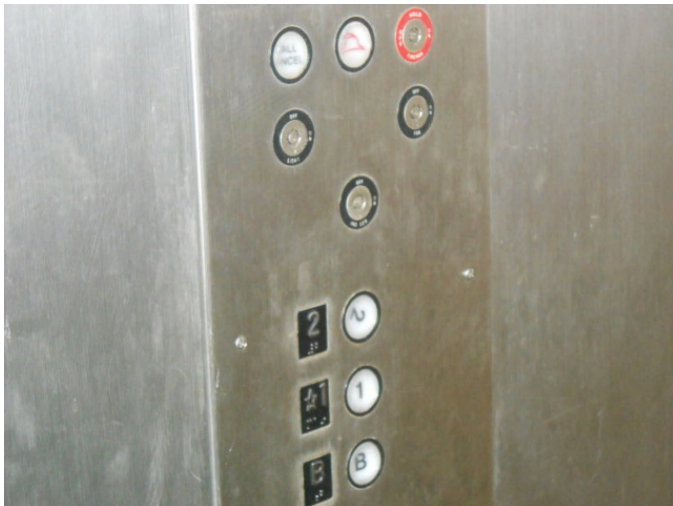
**System: D1010 - Elevators and Lifts**

**Location:** Elevator

**Distress:** Beyond Service Life

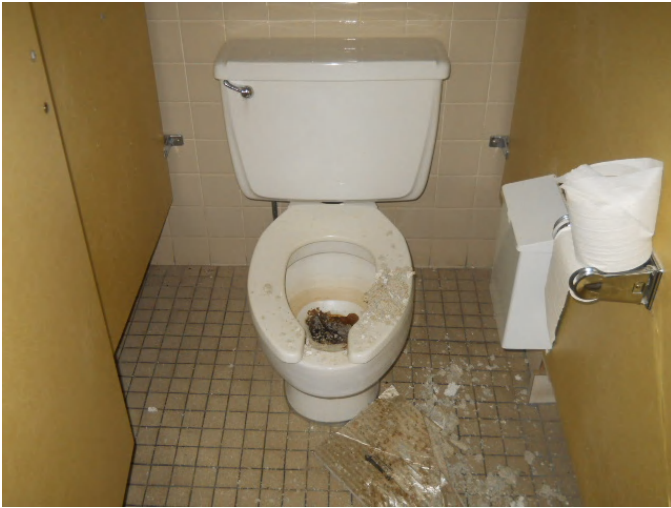
**System: D2010 - Plumbing Fixtures**

**Location:** Restrooms

**Distress:** Beyond Service Life

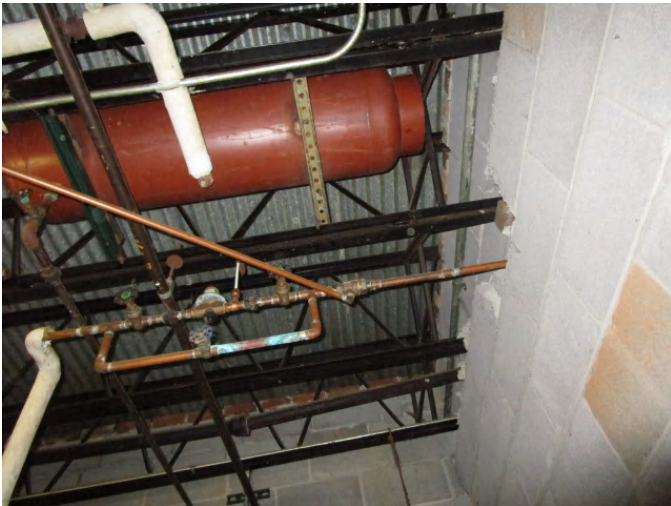
**System: D2020 - Domestic Water Distribution**

**Location:** Throughout Building

**Distress:** Beyond Service Life

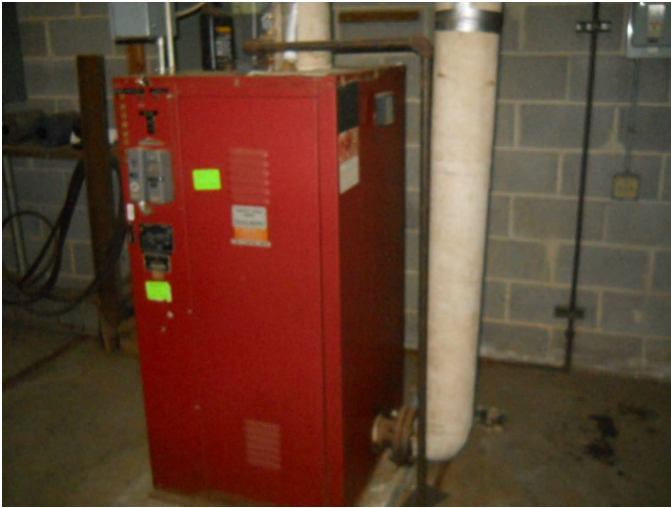
**System: D3020 - Heat Generating Systems**

**Location:** Mechanical Room

**Distress:** Beyond Service Life

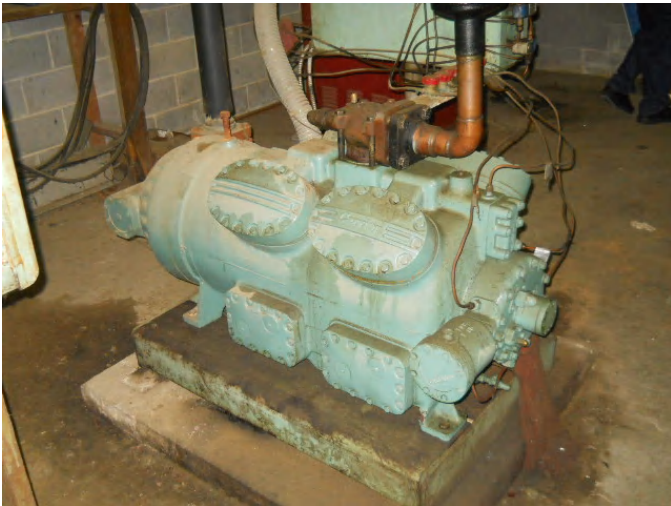
**System: D3030 - Cooling Generating Systems**

**Location:** Mechanical Room

**Distress:** Beyond Service Life

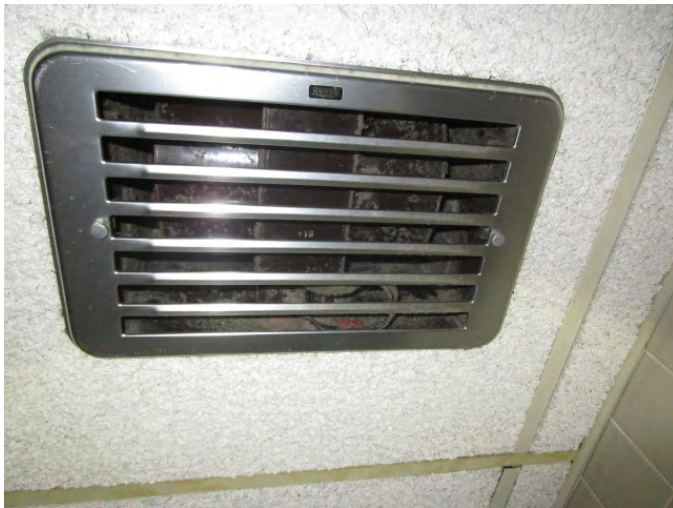
**System: D3040 - Distribution Systems & Exhaust Systems**

**Location:** Throughout Building

**Distress:** Beyond Service Life

**Notes:** The HVAC distribution systems are beyond their service life and should be replaced.

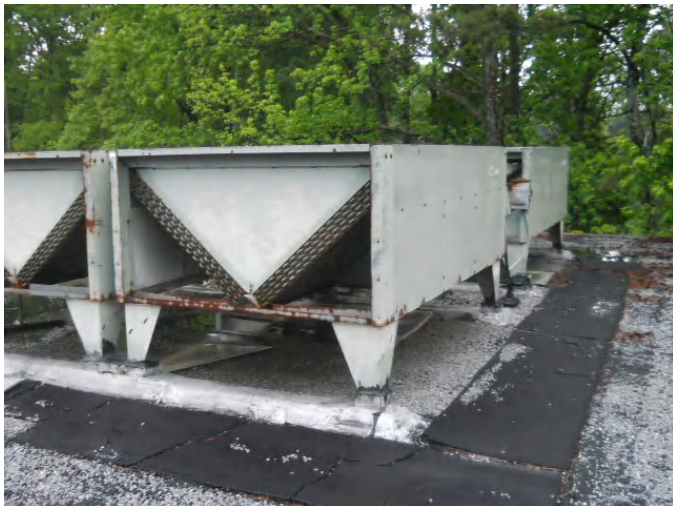
**System: D3050 - Terminal & Package Units**

**Location:** Roof

**Distress:** Beyond Service Life

**Notes:** The terminal and package units are beyond expected service life and should be replaced.

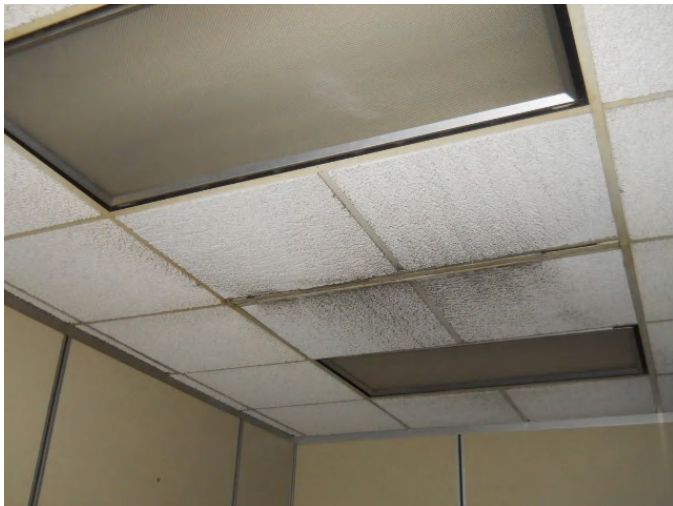
**System: D5020 - Lighting**

**Location:** Throughout Building

**Distress:** Beyond Service Life

**Notes:** The lighting system is beyond its expected service life, inefficient, and should be replaced.

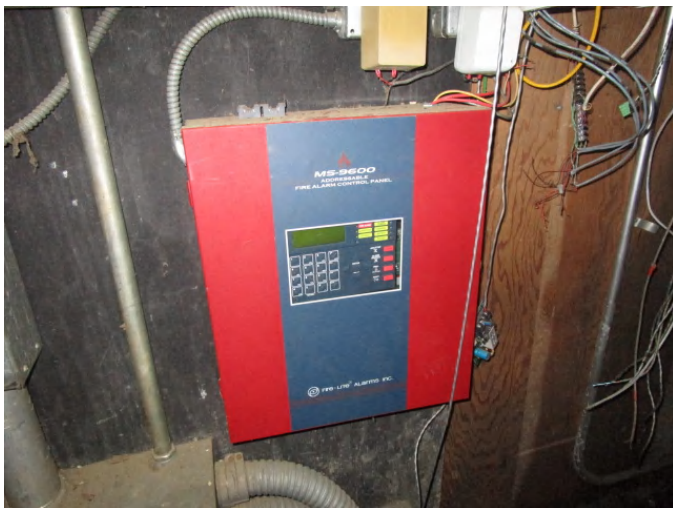
**System: D5030 - Communications and Security - Fire Alarm**

**Location:** Throughout Building

**Distress:** Beyond Service Life

**Notes:** The fire alarm panel, located in Building A, is beyond its service life and should be replaced.

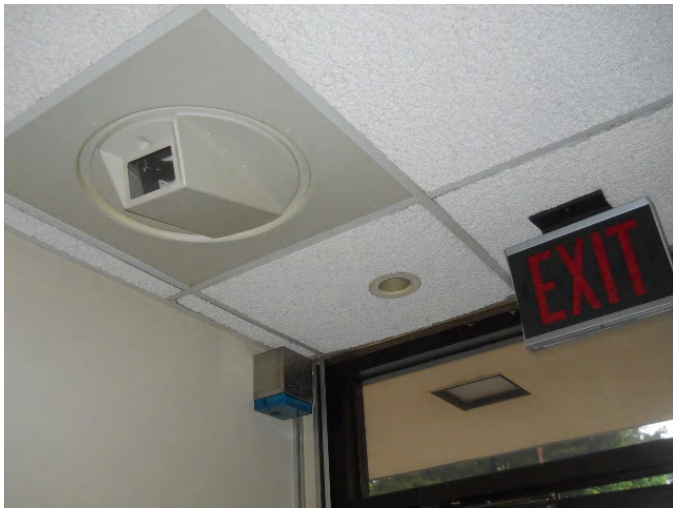
**System: D5030 - Communications and Security - Security & CCTV**

**Location:** Throughout Building

**Distress:** Beyond Service Life

**Notes:** Security and CCTV systems are beyond their expected service life and should be scheduled for replacement.

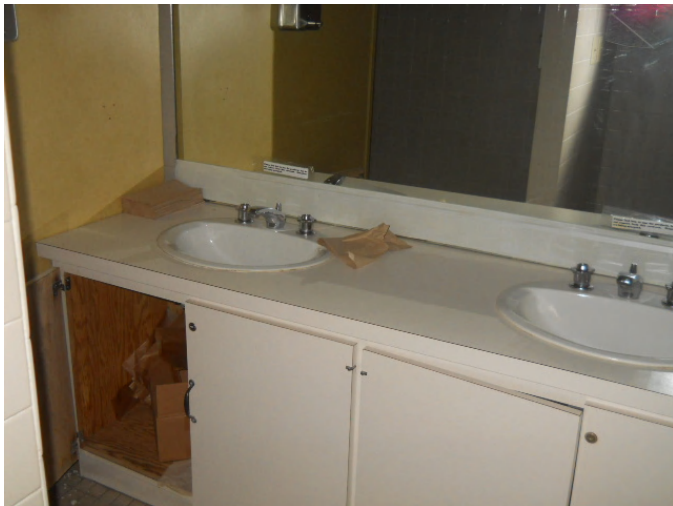
**System: E2010 - Fixed Furnishings**

**Location:** Throughout Building

**Distress:** Beyond Service Life

**Notes:** The fixed furnishings are beyond their expected service life and should be replaced.

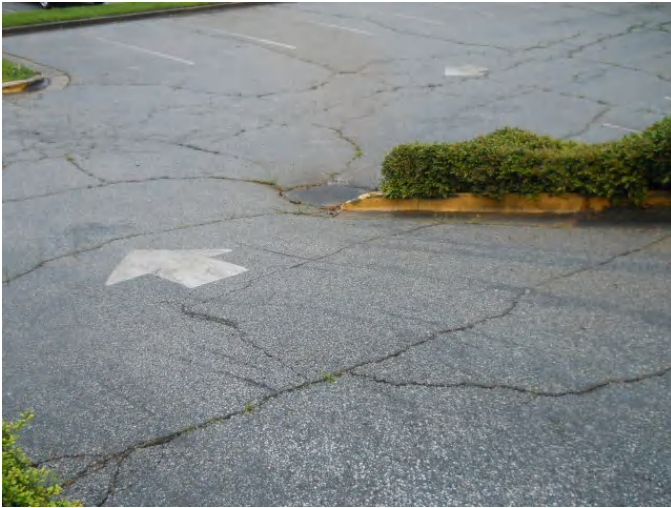
#### System: G2010 - Roadways

**Location:** Site

**Distress:** Beyond Service Life

**Notes:** The roadways are beyond their service life, deteriorated, and should be scheduled for replacement.

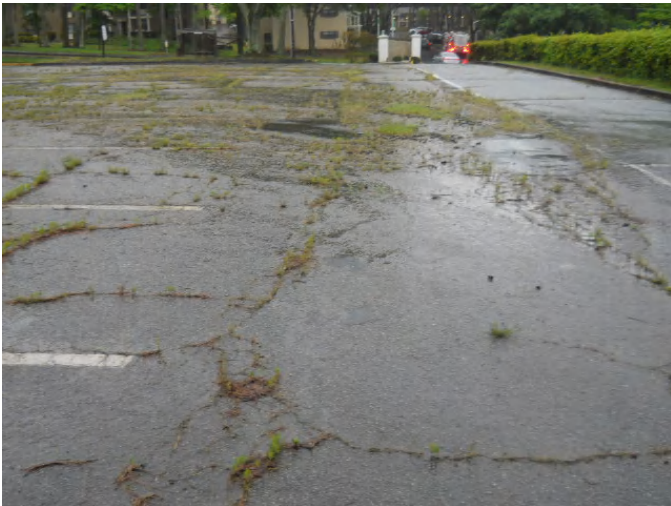
#### System: G2020 - Parking Lots

**Location:** Site

**Distress:** Beyond Service Life

**Notes:** The parking lot is deteriorated, not ADA compliant, and should be scheduled for replacement.

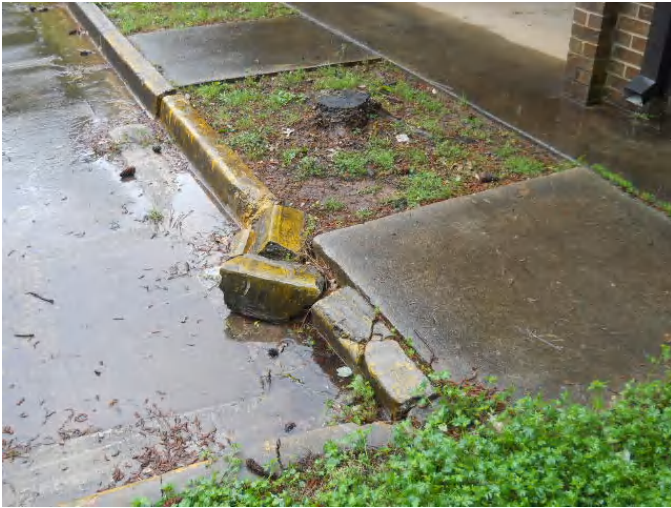
**System: G2030 - Pedestrian Paving**

**Location:** Site

**Distress:** Beyond Service Life

**Notes:** Pedestrian paving is beyond its service life, has not been maintained, is not ADA compliant, and should be scheduled for replacement.

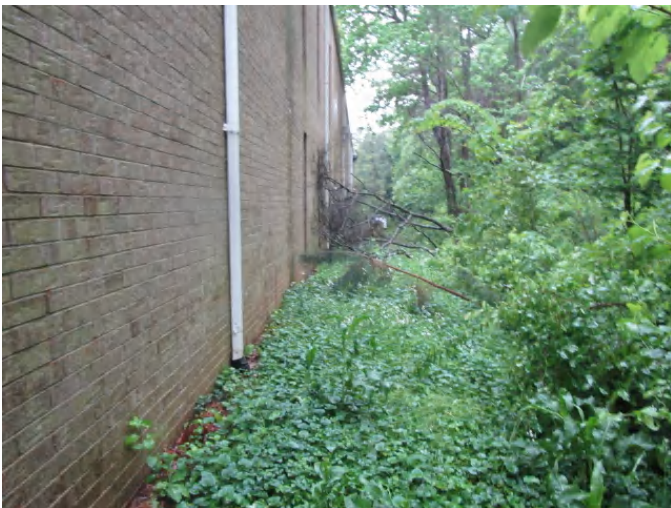
**System: G2050 - Landscaping**

**Location:** Site

**Distress:** Beyond Service Life

**Notes:** The buildings are vacant and the landscaping has not been maintained and should be replaced.

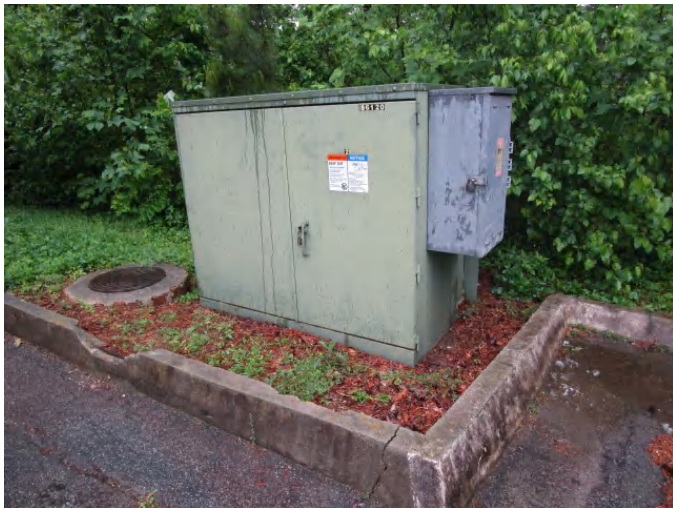
**System: G4010 - Electrical Distribution**

**Location:** Site

**Distress:** Beyond Service Life

**Notes:** The electrical distribution system is beyond its expected service life and should be scheduled for replacement.

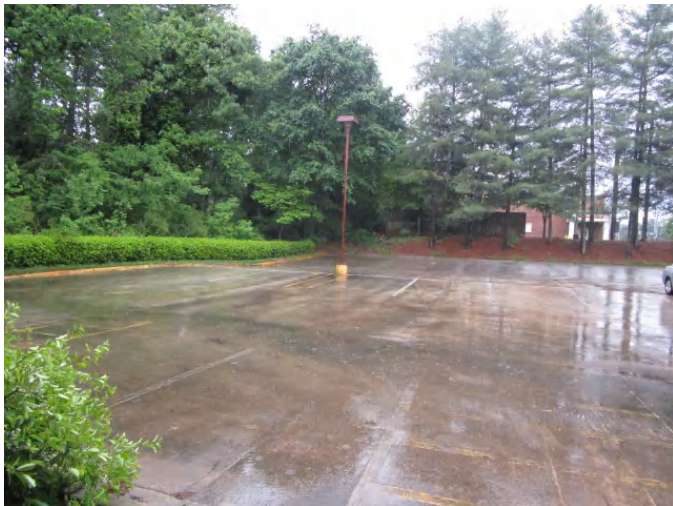
**System: G4020 - Site Lighting**

**Location:** Site

**Distress:** Beyond Service Life

**Notes:** Site lighting is original, beyond its service life, and should be scheduled for replacement.

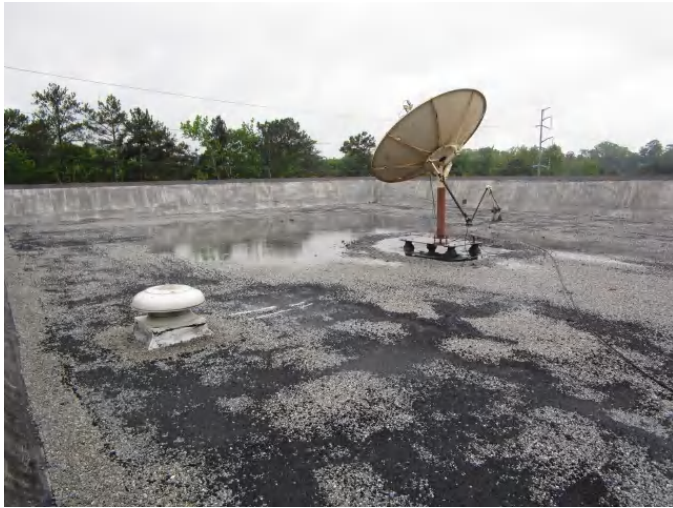
**System: G4030 - Site Communications & Security**

**Location:** Roof

**Distress:** Beyond Service Life

**Notes:** The site communications and security systems are beyond their expected service life and should be scheduled for replacement.
