DeKalb County School District/Elementary Schools

Henderson Mill Elementary

School Assessment Report
May 19, 2016

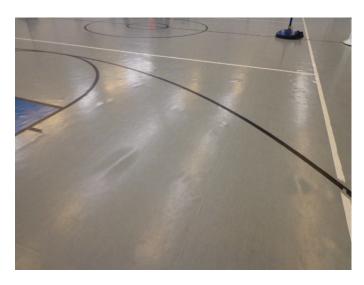
Location: Basketball Court

System: C3020 - Floor Finishes - Neoprene

Distress: Beyond Service Life

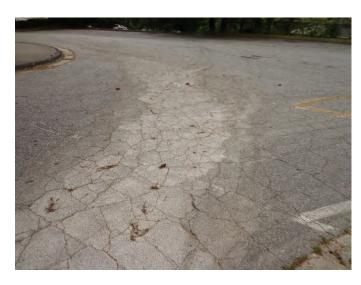
Location: Site

System: G2010 - Roadways

Distress: Beyond Service Life

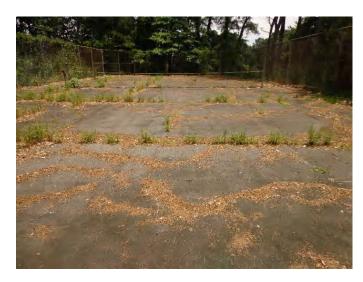
Location: Site

System: G2040 - Tennis Courts

Distress: Beyond Service Life
