# James R. Hallford Stadium

## School Assessment Report

May 20, 2016

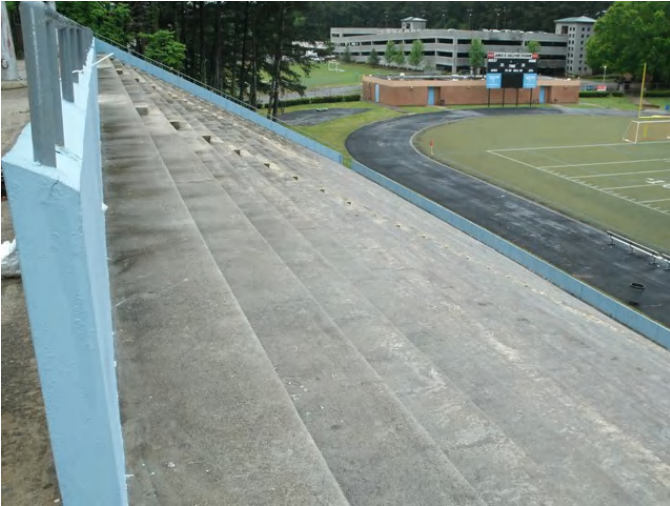
**System: B2010 - Exterior Walls**

**Location:** Exterior Surfaces

**Distress:** Needs Remediation

**Notes:** The exterior surfaces are stained and need to be pressure washed and repainted.

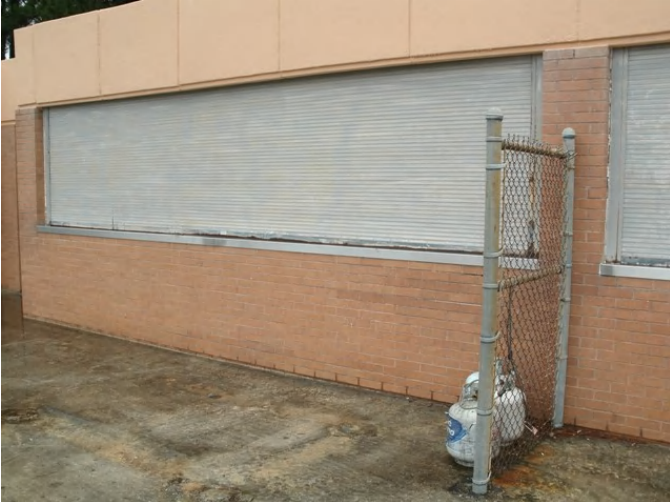
**System: B2020 - Exterior Windows**

**Location:** East Stand

**Distress:** Beyond Service Life

**Notes:** The exterior windows are beyond their expected service life and should be scheduled for replacement.

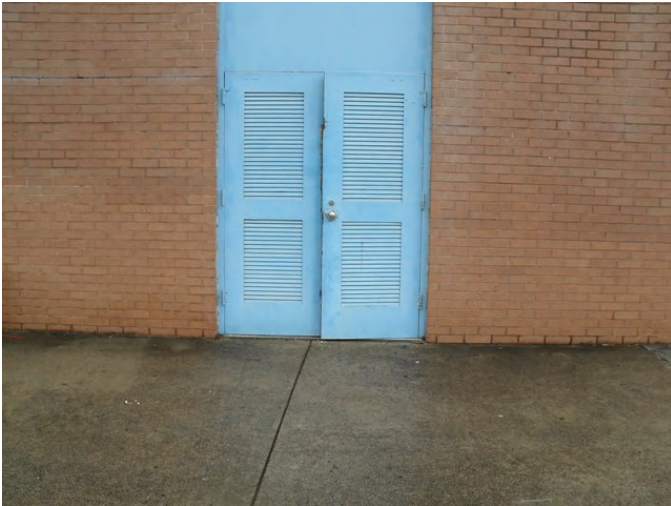
#### **System: B2030 - Exterior Doors**

**Location:** Field House

**Distress:** Beyond Service Life

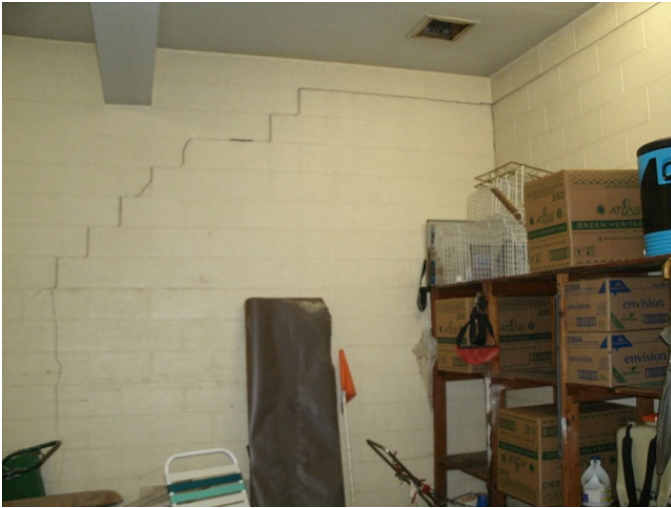
### **System: C1010 - Partitions**

**Location:** Field House

**Distress:** Damaged

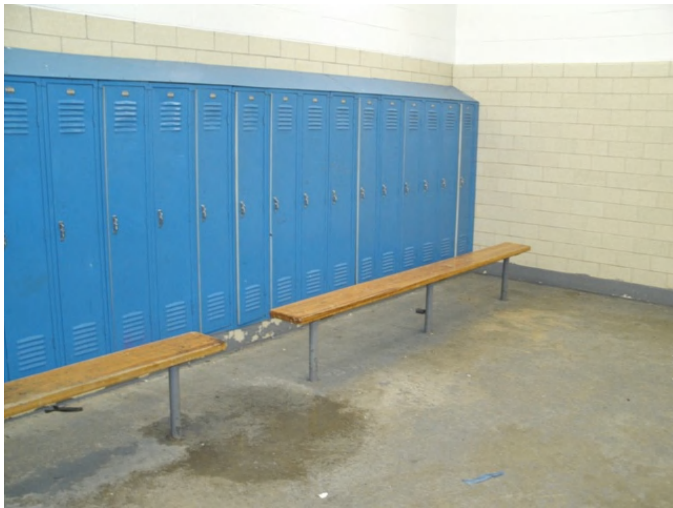
**System: C1030 - Fittings**

**Location:** Throughout Building

**Distress:** Beyond Service Life

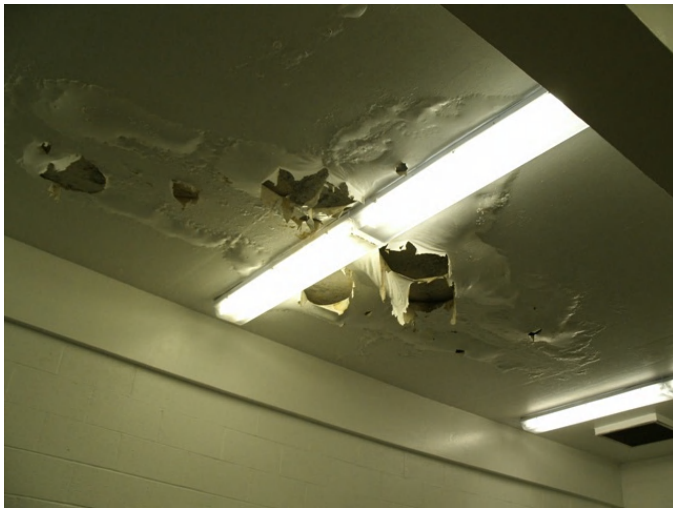
**System: C3030 - Ceiling Finishes**

**Location:** Field House

**Distress:** Damaged

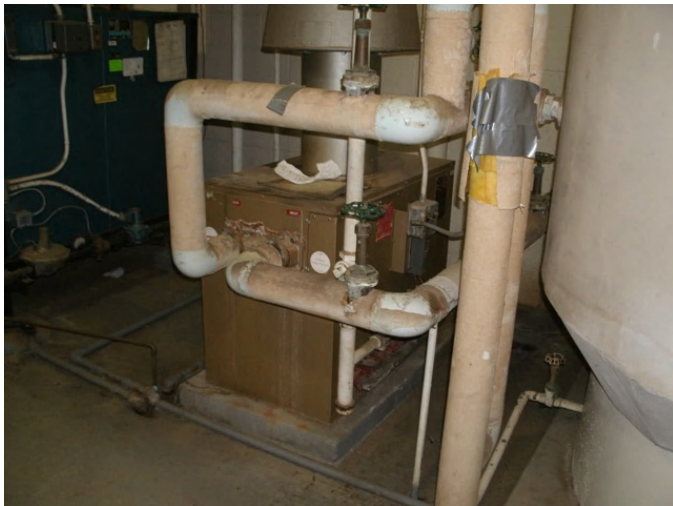
**System: D2020 - Domestic Water Distribution**

**Location:** Field House

**Distress:** Beyond Service Life

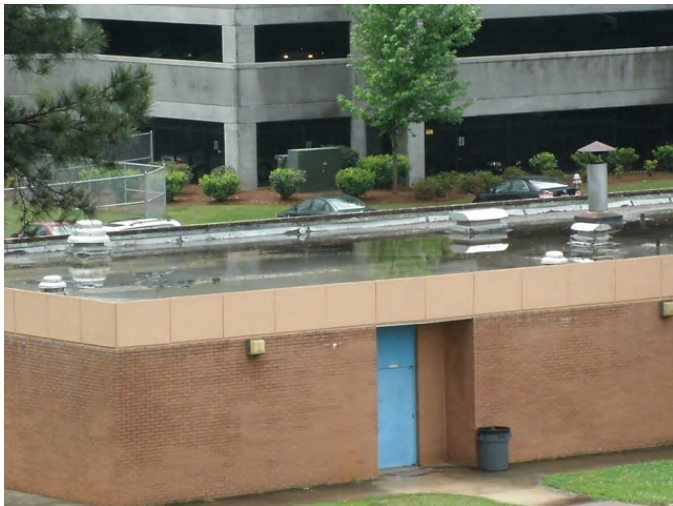
**System: D2040 - Rain Water Drainage**

**Location:** Field House

**Distress:** Damaged

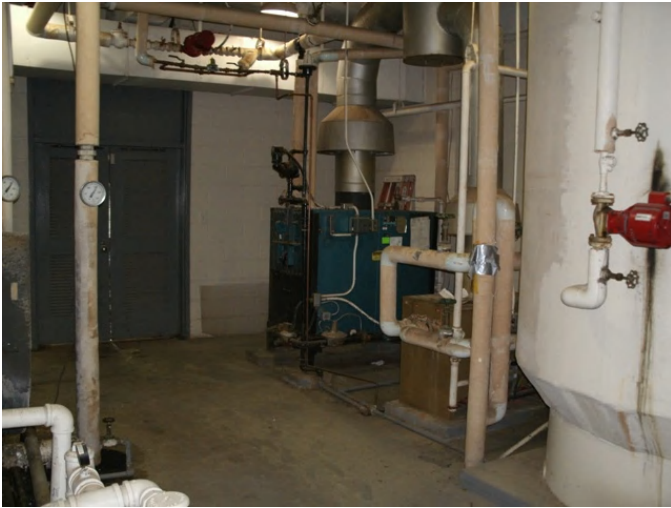
**System: D3050 - Heat Generation**

**Location:** Field House

**Distress:** Beyond Service Life

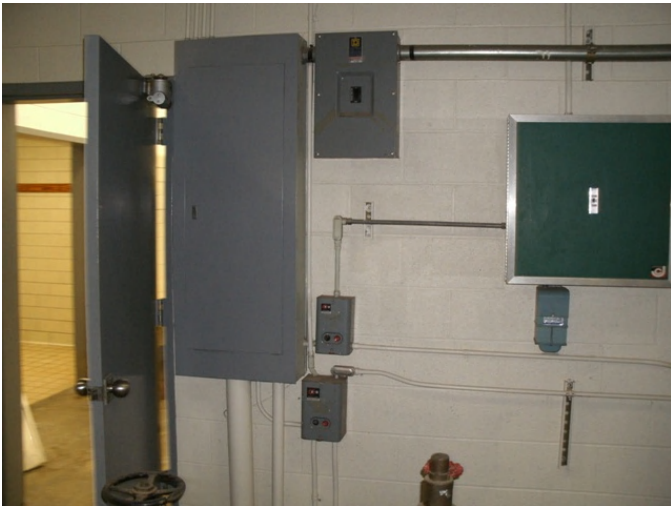
**System: D3060 - Controls & Instrumentation**

**Location:** Field House

**Distress:** Beyond Service Life

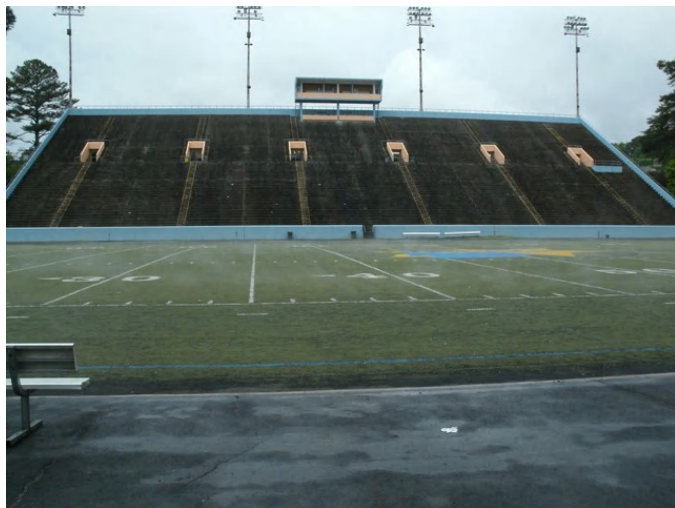
#### System: C2010 - Stair Construction

**Location:** West Stand Stadium

**Distress:** Inadequate

**Notes:** The stadium steps, access ramps, and stairs do not have adequate railing, are damaged, and do not provide ADA accessibility to all areas.

**Correction:** Replace stadium stairs (\$2.08/sf)

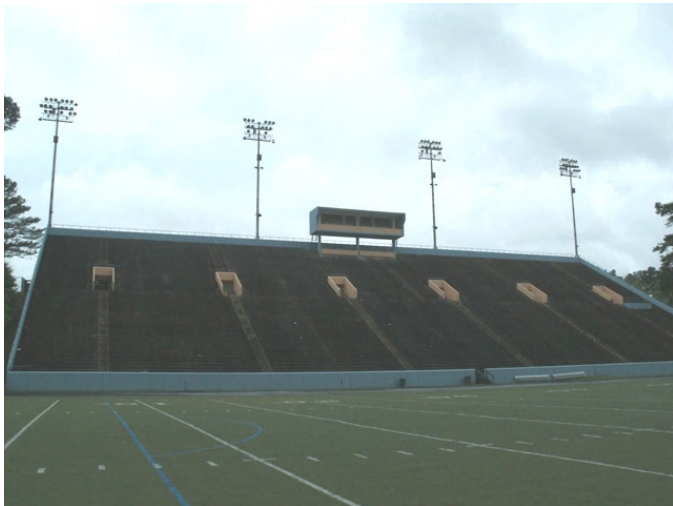
**System: B2010 - Exterior Walls**

**Location:** Exterior Surfaces

**Distress:** Needs Remediation

**Notes:** The seating area is in poor condition and should be cleaned and repainted.

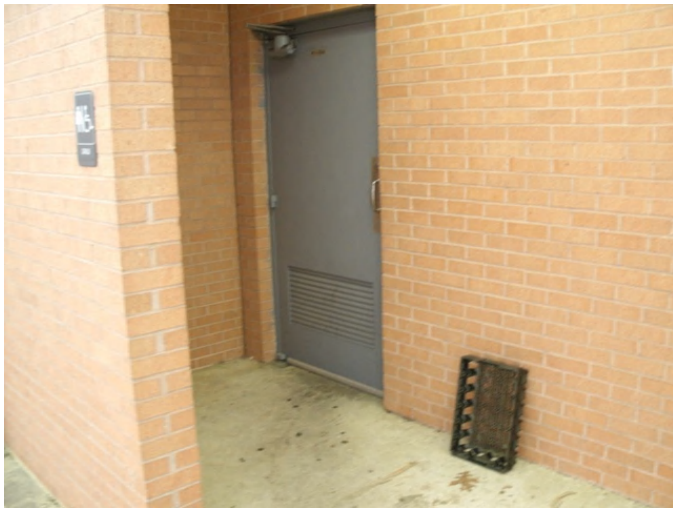
**System: B2030 - Exterior Doors**

**Location:** West Stand

**Distress:** Beyond Service Life

**Notes:** The exterior doors are beyond their expected service life, not ADA compliant, and should be scheduled for replacement.

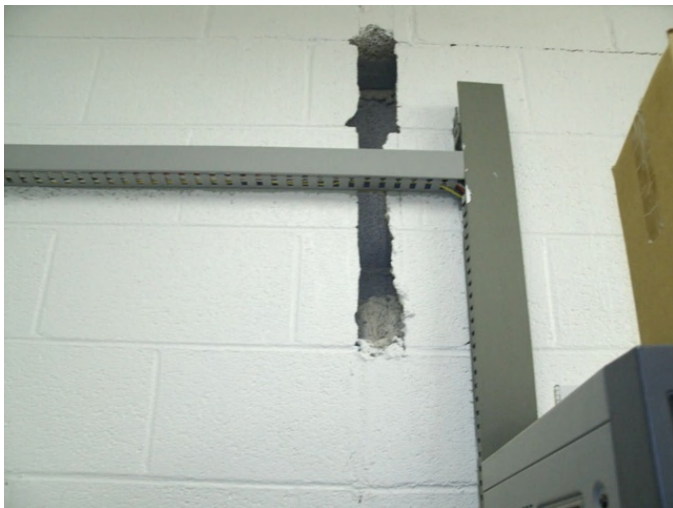
**System: C1010 - Partitions**

**Location:** West Stand

**Distress:** Damaged

**Notes:** The partitions are damaged and should be scheduled for replacement.

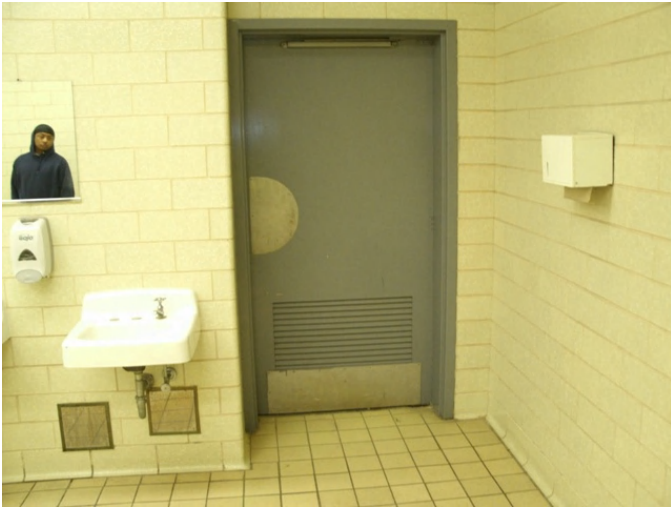
**System: C1020 - Interior Doors**

**Location:** Throughout Building

**Distress:** Beyond Service Life

**Notes:** The interior doors are beyond their expected service life and should be scheduled for replacement.

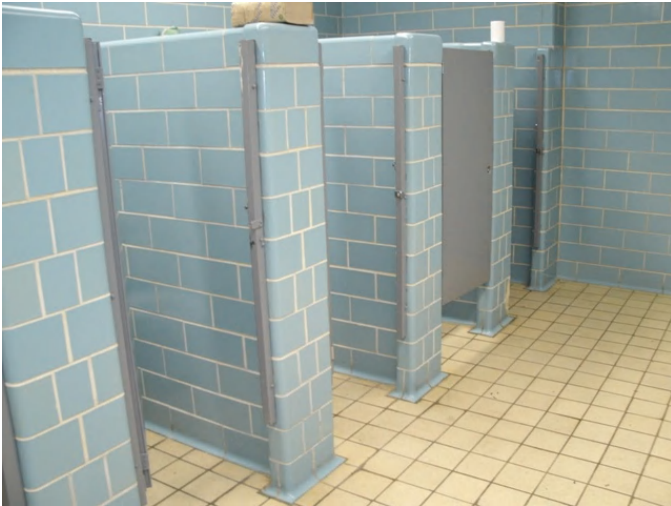
**System: C1030 - Fittings**

**Location:** West Stand

**Distress:** Beyond Service Life

**Notes:** Fittings, such as toilet partitions and handrails, are beyond their expected service life, not ADA compliant, and should be scheduled for replacement.

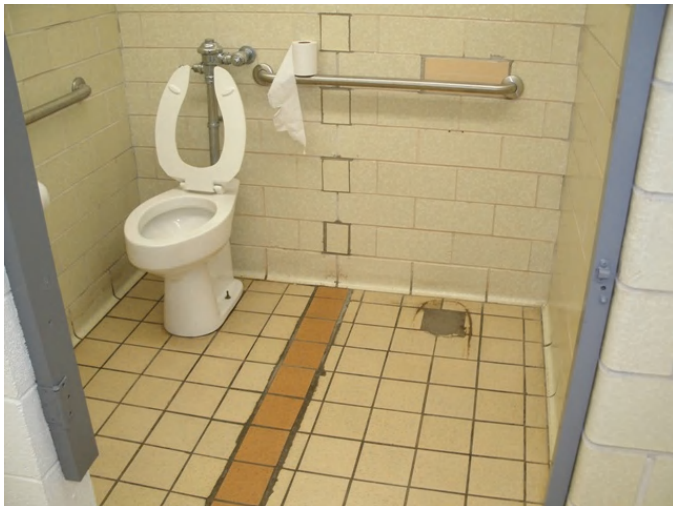
**System: D2010 - Plumbing Fixtures**

**Location:** Throughout Building

**Distress:** Beyond Service Life

**Notes:** The plumbing fixtures are beyond service life, inadequate, not ADA compliant, and should be scheduled for replacement.

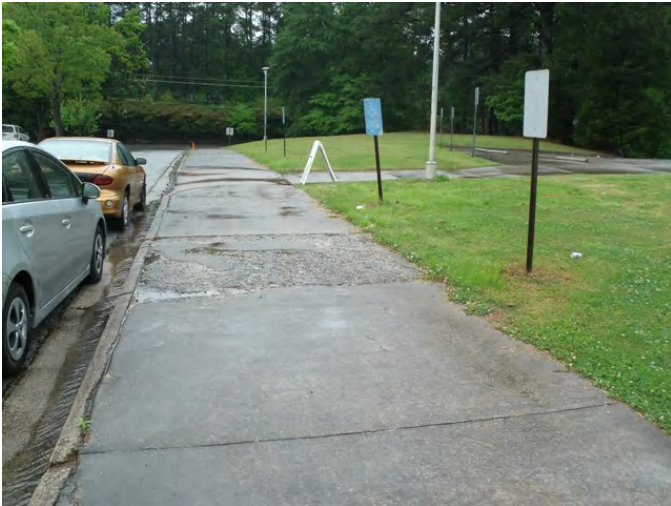
#### System: G2030 - Pedestrian Paving

**Location:** Site

**Distress:** Beyond Service Life

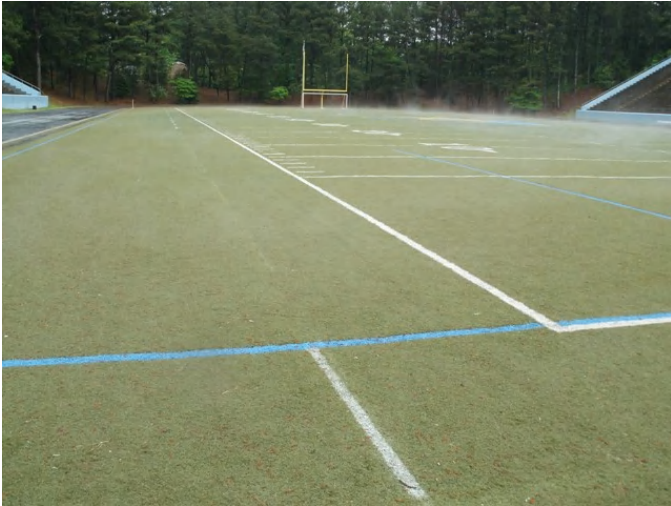
**System: G2040 - Football Field**

**Location:** Football Field

**Distress:** Damaged

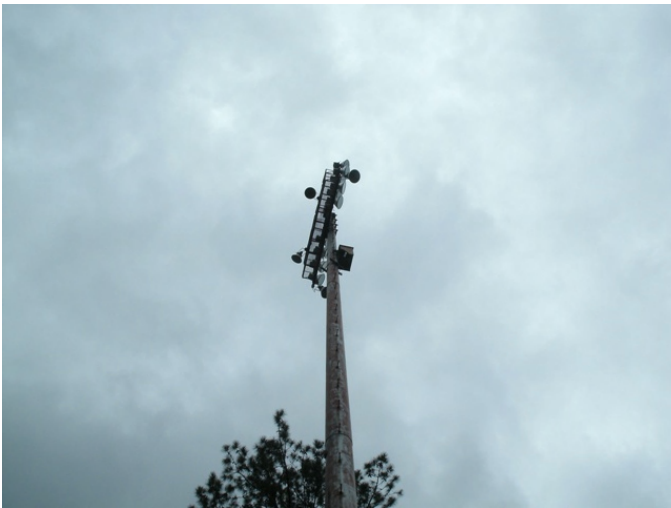
**System: G4020 - Site Lighting**

**Location:** Site

**Distress:** Damaged

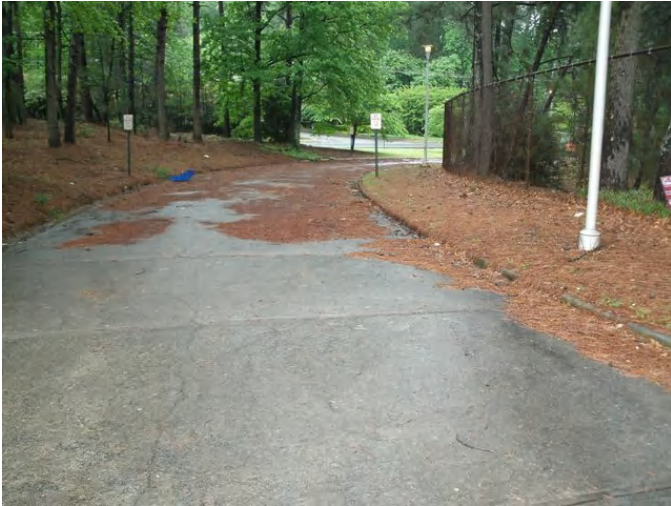
**System: G2010 - Roadways**

**Location:** Site

**Distress:** Beyond Service Life

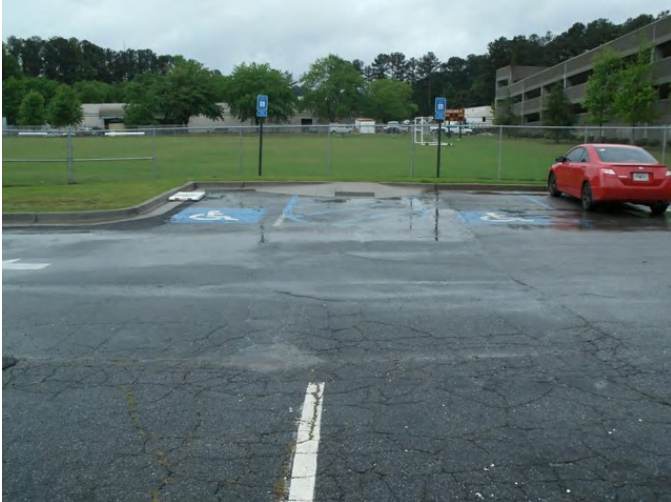
**System: G2020 - Parking Lots**

**Location:** Site

**Distress:** Beyond Service Life

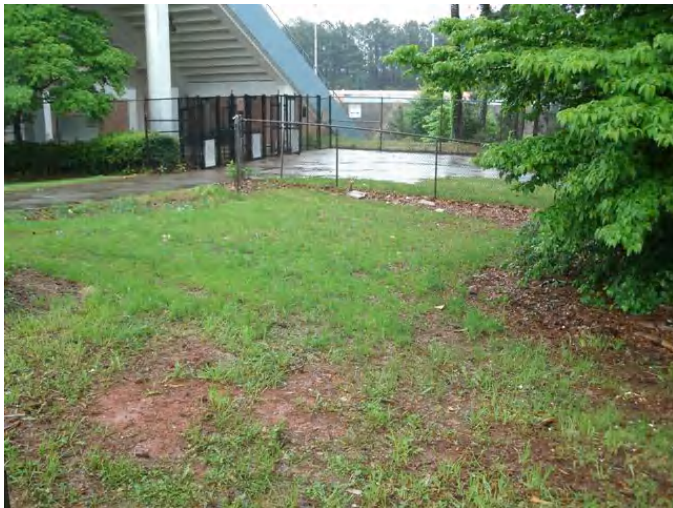
### **System: G2040 - Fencing & Guardrails**

**Location:** Site

**Distress:** Beyond Service Life

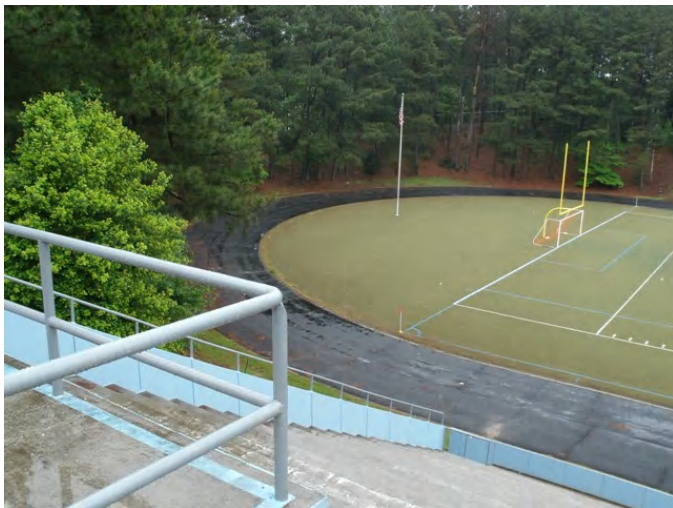
### **System: G2040 - Track**

**Location:** Track

**Distress:** Inadequate

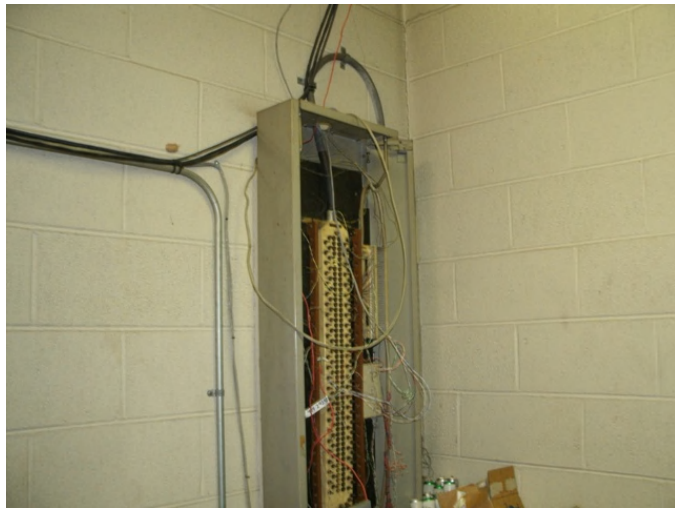
**System: G4030 - Site Communications & Security**

**Location:** Site

**Distress:** Beyond Service Life
