**DeKalb County School District/Middle Schools**

# **Miller Grove Middle**

## **School Assessment Report**

**May 20, 2016**

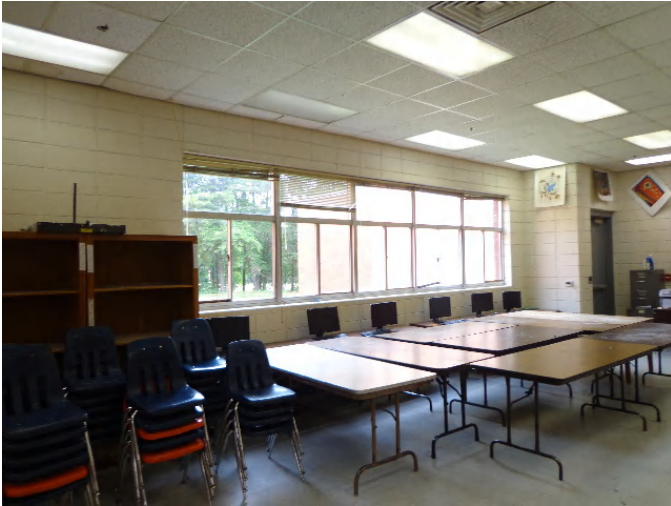
**System: B2020 - Exterior Windows**

**Location:** Throughout Building

**Distress:** Beyond Service Life

**Notes:** The exterior windows are aged, rusted, not energy efficient, and should be replaced. Most windows have broken lock mechanisms.

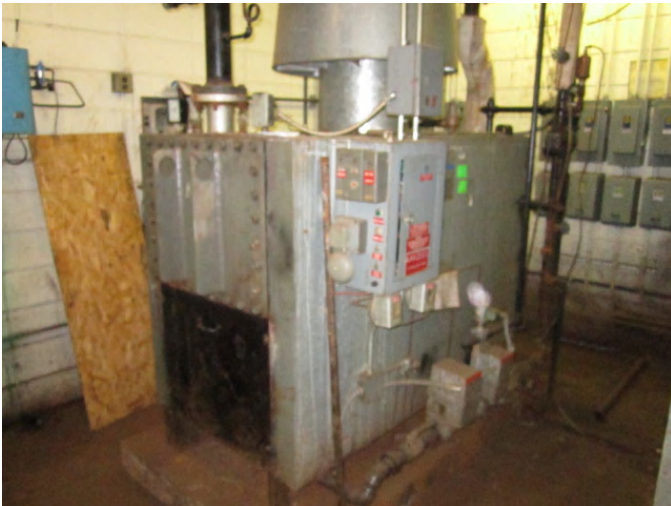
**System: D3020 - Heat Generating Systems**

**Location:** Throughout Building

**Distress:** Beyond Service Life

**Notes:** Heat generating systems are beyond their expected service life and should be scheduled for replacement. White mastic on fiberglass pipe insulation is identified as ACM by others. SPLOST project 122-422 to replace the HVAC systems.

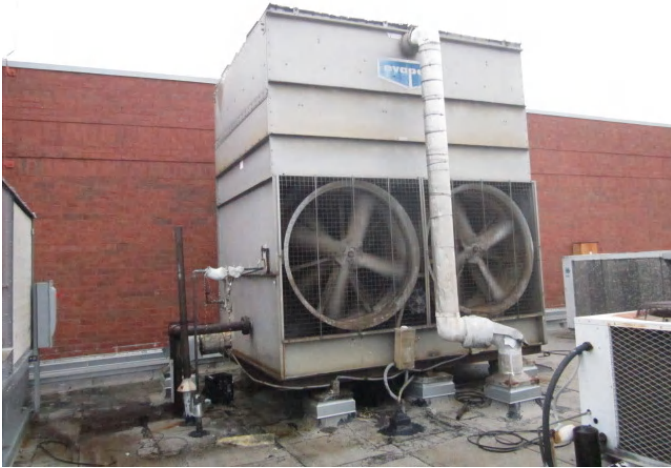
**System: D3030 - Cooling Generating Systems**

**Location:** Throughout Building

**Distress:** Beyond Service Life

**Notes:** The cooling generating system is system is beyond its expected service life and should be scheduled for replacement. White mastic on fiberglass pipe insulation is identified as ACM by others. SPLOST project 122-422 to replace the HVAC systems.

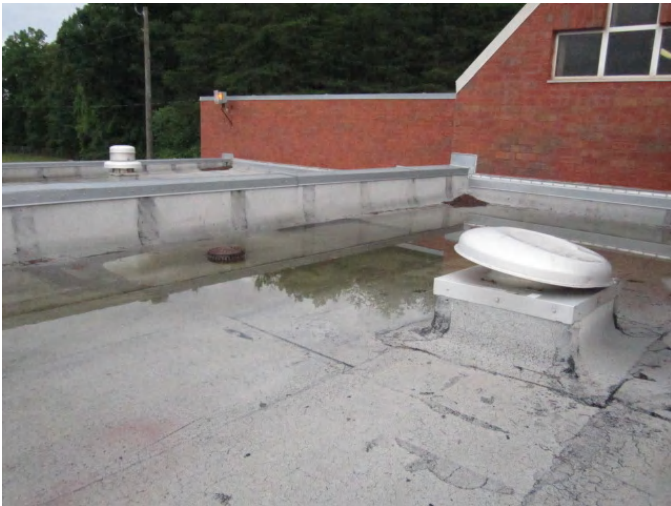
**System: D3040 - Distribution Systems & Exhaust Systems**

**Location:** Throughout Building

**Distress:** Beyond Service Life

**Notes:** Distribution and exhaust systems are beyond their expected service life and should be scheduled for replacement. White mastic on fiberglass pipe insulation is identified as ACM by others.

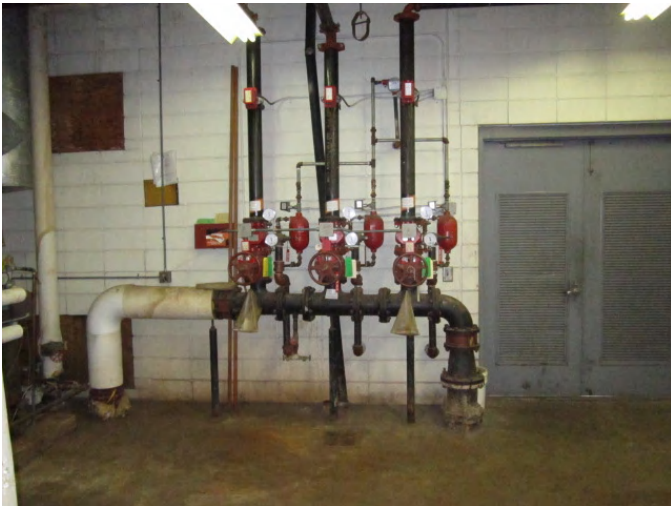
**System: D4010 - Sprinklers**

**Location:** Throughout Building

**Distress:** Beyond Service Life

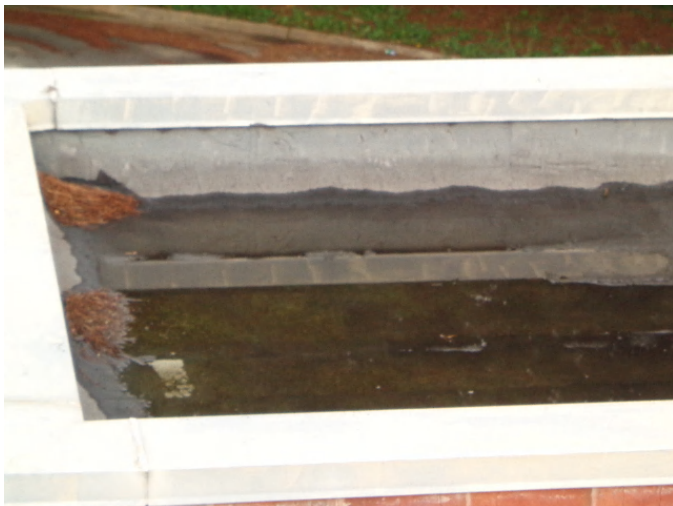
#### **System: B3010 - Roof Coverings - BUR**

**Location:** Roof

**Distress:** Beyond Service Life

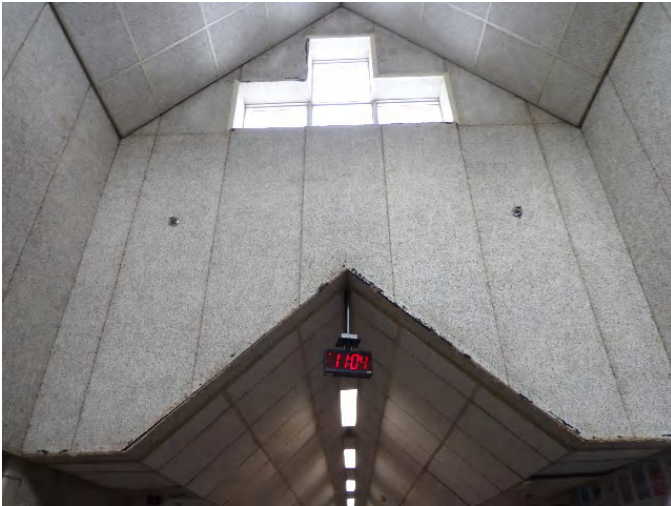
**System: C3030 - Ceiling Finishes**

**Location:** Throughout Building

**Distress:** Beyond Service Life

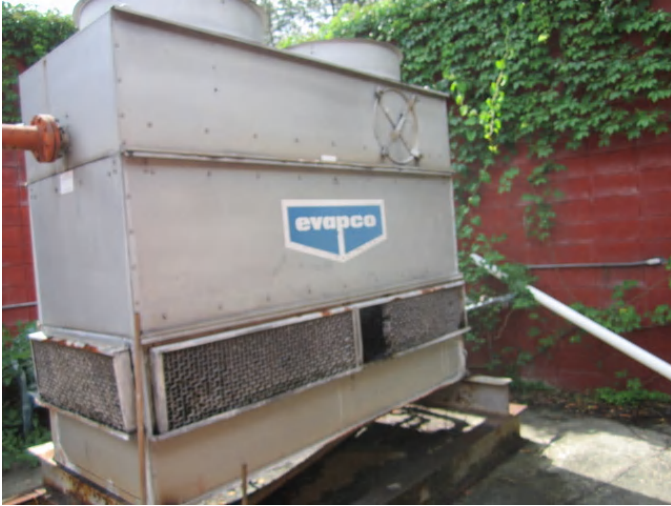
**System: D3030 - Cooling Generating Systems**

**Location:** North Side of Building

**Distress:** Beyond Service Life

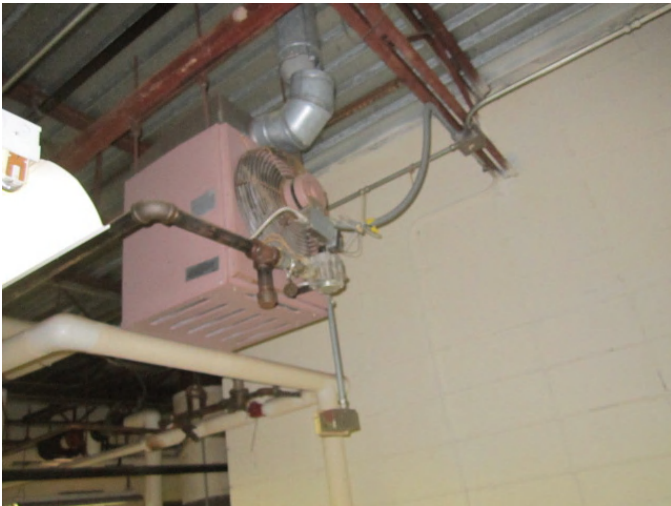
**System: D3050 - Terminal & Package Units**

**Location:** Throughout Building

**Distress:** Beyond Service Life

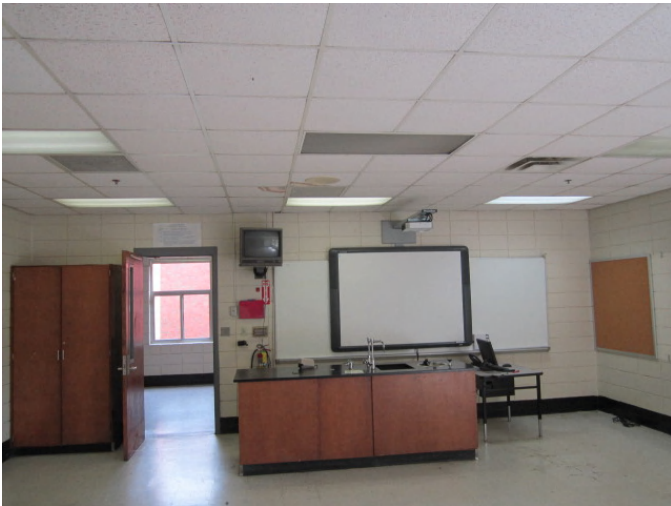
**System: D5020 - Lighting**

**Location:** Throughout Building

**Distress:** Beyond Service Life

**Notes:** The lighting system is beyond its expected service life and should be scheduled for replacement. A large percentage of light fixtures are not functional.

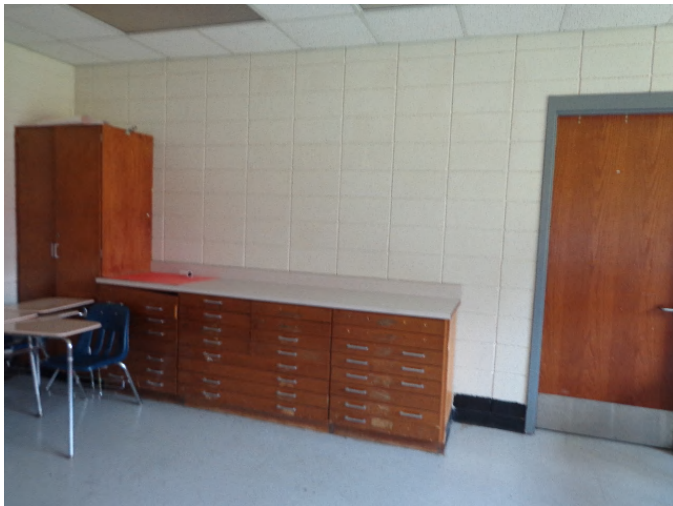
**System: E2010 - Fixed Furnishings**

**Location:** Throughout Building

**Distress:** Beyond Service Life

**Notes:** Fixed furnishings are beyond their expected service life and should be scheduled for replacement.

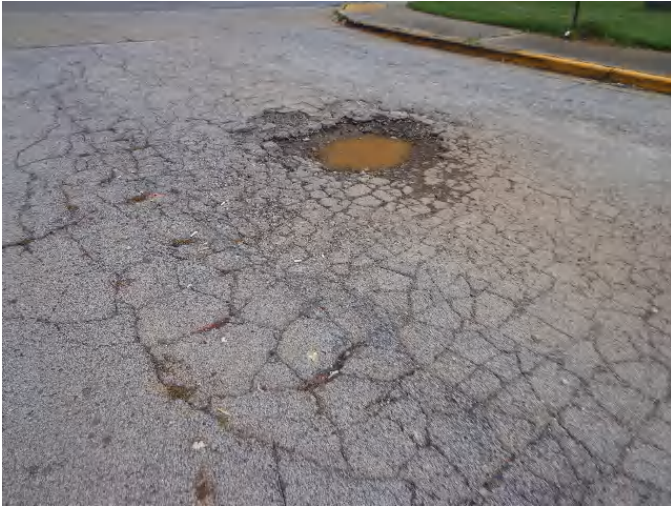
**System: G2010 - Roadways**

**Location:** Site

**Distress:** Beyond Service Life

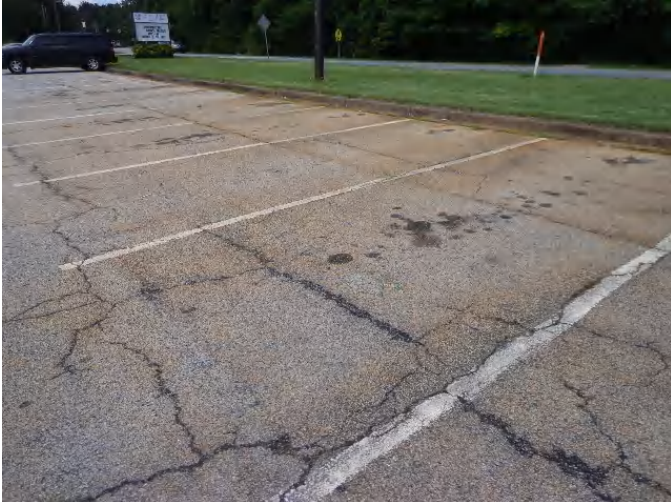
**System: G2020 - Parking Lots**

**Location:** Site

**Distress:** Beyond Service Life

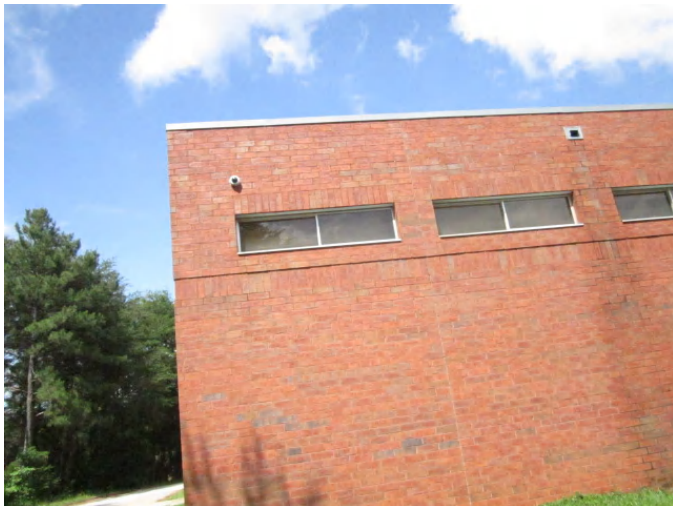
### **System: G4030 - Site Communications & Security**

**Location:** Site

**Distress:** Beyond Service Life
