DeKalb County School District/High Schools

Southwest DeKalb High

School Assessment Report
May 20, 2016

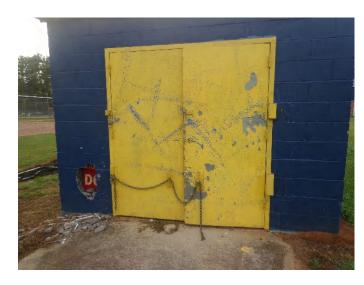
System: B2030 - Exterior Doors

Location: Exterior Walls

Distress: Beyond Service Life

Notes: The original exterior doors are aged, rusted, and should be replaced. SPLOST project 514-422 to install new windows, doors and hardware.

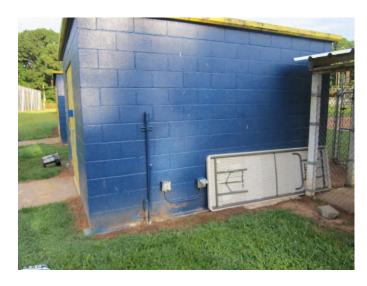
System: D5010 - Electrical Service/Distribution

Location: Throughout Building

Distress: Beyond Service Life

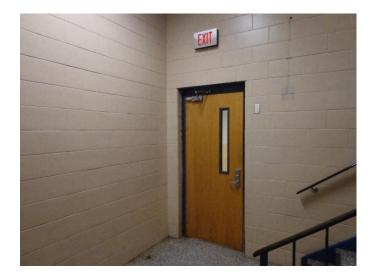
System: C1020 - Interior Doors

Location: Stair #6

Distress: Needs Remediation

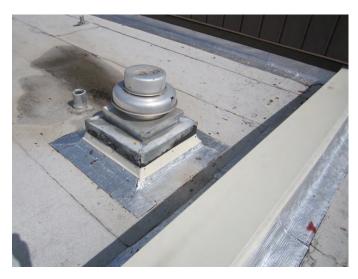
System: D3040 - Distribution Systems & Exhaust Systems

Location: Throughout Building

Distress: Beyond Service Life

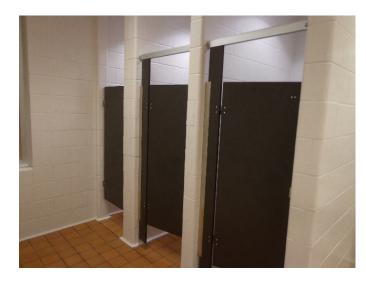
System: C1030 - Fittings

Location: First Floor Restrooms

Distress: Needs Remediation

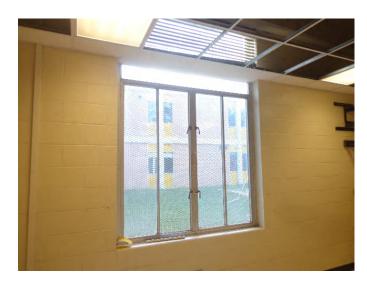
System: B2020 - Exterior Windows

Location: Throughout Building

Distress: Beyond Service Life

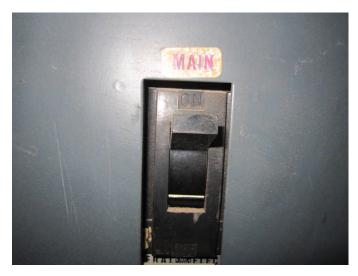
System: D5010 - Electrical Service/Distribution

Location: Main Switch Room/Throughout Building

Distress: Beyond Service Life

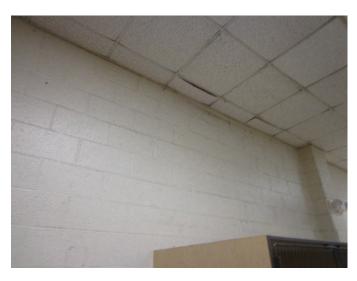
System: C3010 - Wall Finishes - Paint

Location: Throughout Building

Distress: Beyond Service Life

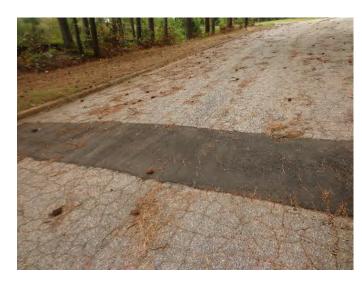
Location: Site

System: G2010 - Roadways

Distress: Beyond Service Life

Correction: Replace/resurface asphalt roadway
